Village of Questa

Facility Assessment Report La Cienega Gymnasium

Questa, NM

Date: September 18, 2023

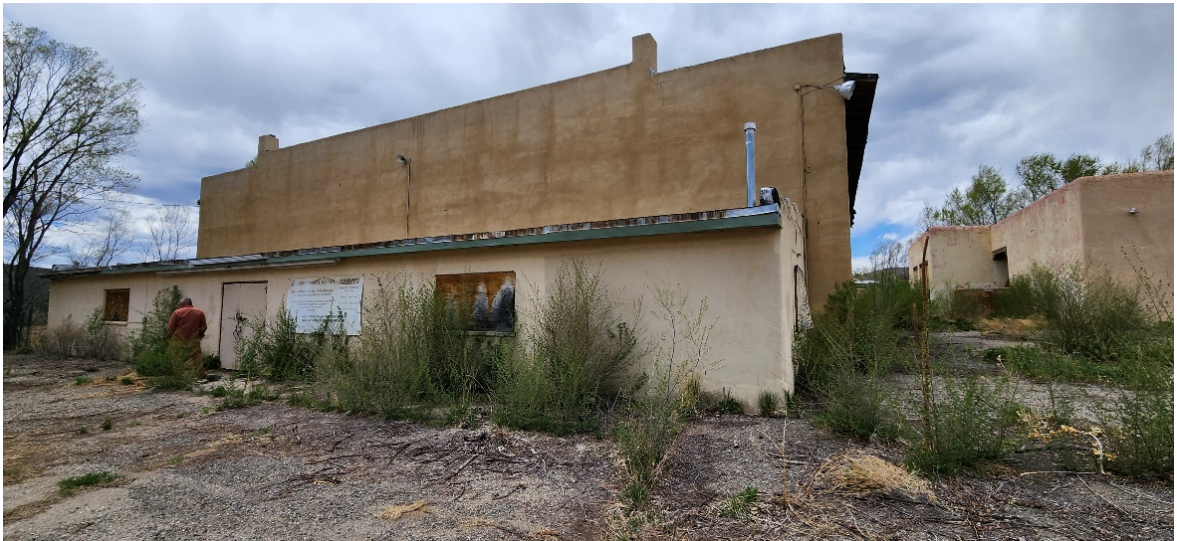
Parking Lot

The asphalt pavement for the existing parking lot is deteriorating, cracking and has vegetation growing up through the cracks as shown below. There is also an existing concrete slab for a play court in the parking lot that has cracked and has vegetation growing up through it. The slab is in better condition than the surrounding asphalt. Overgrown vegetation surrounds the building and needs to be removed. The roof runoff sheet flows off the roof and is causing minor water damage and erosion to the stucco on the base of the building as shown in photo below. The roof runoff also appears to be causing water damage and potential water intrusion to the door located on the northeast side of the building as shown in image below.

Due to the condition of the asphalt and the lack of positive grade on the east side of the building we would recommend removing the deteriorated asphalt and concrete slab and regarding the area to support future development.

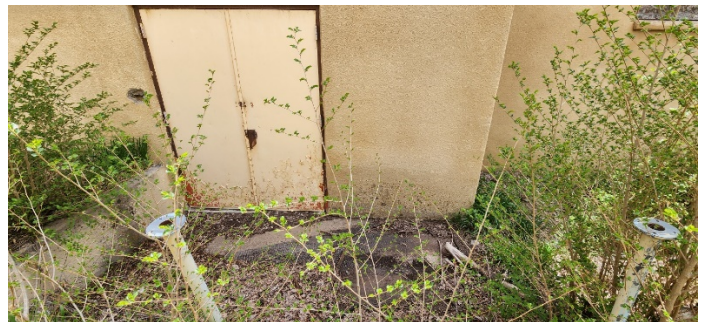
Water damage/intrusion at NE Exterior door

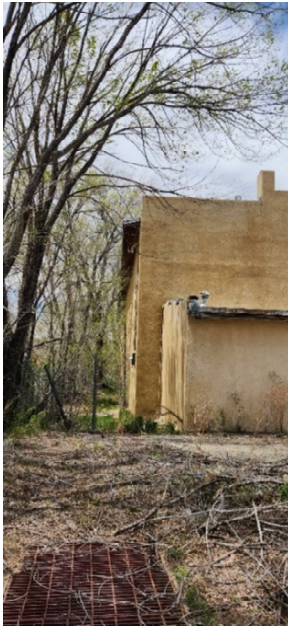
There is an existing storm water inlet at the south side of the parking lot that collects surface runoff from the parking lot. The outlet of the inlet was not found during the site visit and the inlet is filled with debris that needs to be removed. The east side low roof sheets flows off the roof and is most likely causing water intrusion on the double doors. A single piece of gutter has been installed over the doors to direct roof runoff to either side of the doors.

Storm Water Inlet

The roof drainage should be collected via gutters and downspouts and an underground storm drain system should be constructed to connect to the existing inlet in the parking lot. This will alleviate water collecting around the building and keep water from entering doorways. Minor grading on the north, south and west side of the facility is also recommended to ensure positive flow away from the building.

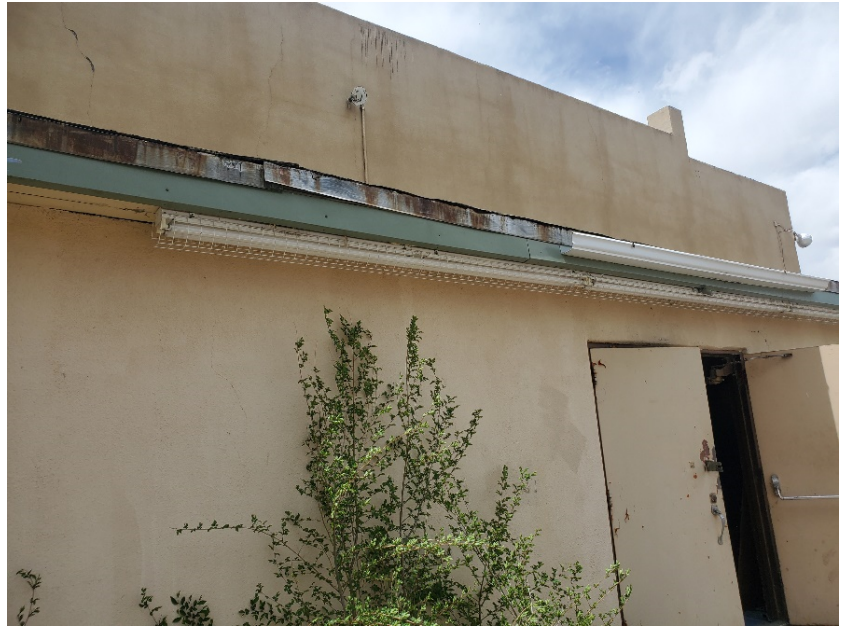
Roof gutter and east door

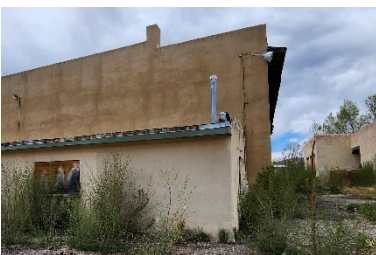
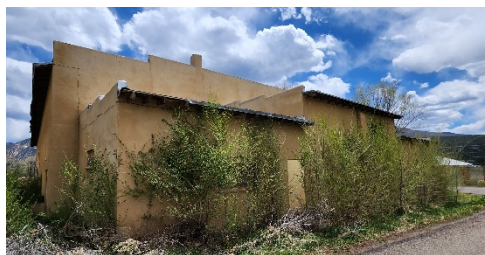
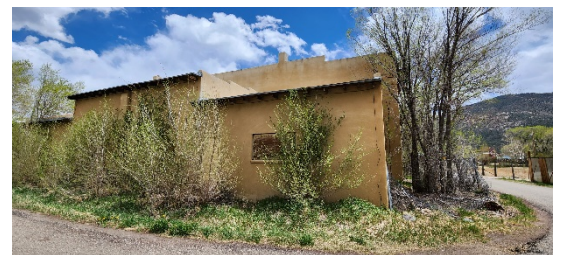
There is extensive overgrowth of vegetation at the building exterior including tree/shrub growth adjacent to the building foundation at all elevations.

Vegetation Overgrowth

Trimming or removal of all vegetation which is potentially damaging or could damage the building is recommended. This includes removal of all trees/bushes currently growing tight to the building footing as well as tree branches overhanging the facility.

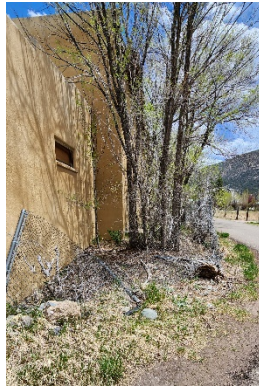
Vegetation Overgrowth/Damaged Fence

Damaged fencing should be replaced at the perimeter of the site and guard rail should be installed at retaining walls near the gymnasium egress doors to protect against falls at this grade change.

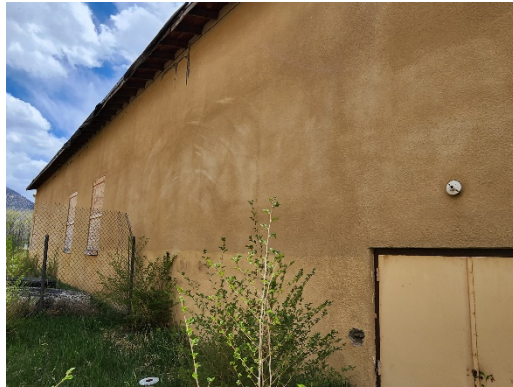
The building exterior wall construction consists of a stucco finish over structural concrete masonry units. The existing stucco finish is in poor condition with areas of cracking and evidence of moisture damage at the vertical wall surfaces. Previous efforts to repair and re-coat the surfaces have led to a buildup of portland cement material at grade level; this condition makes it challenging to determine the state of the wall and foundation at grade.

Stucco Damage

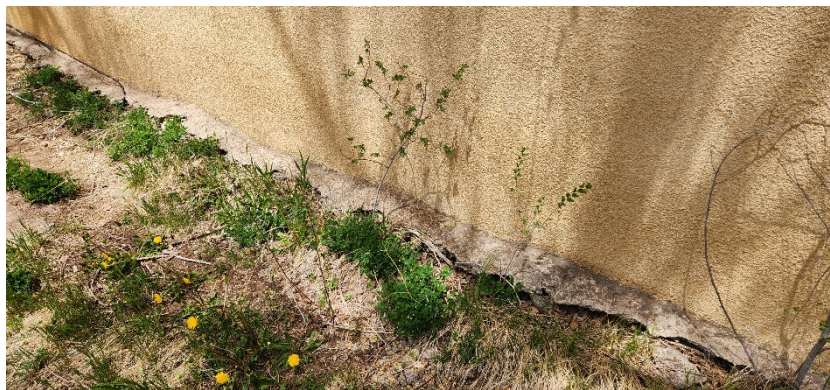
Stucco Condition at Grade

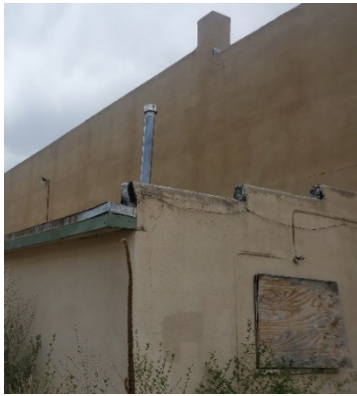
- Roofing shows evidence of patching/repair at termination bars, parapets, and built-up roofing
- Metal fascia and flashing is in disrepair and is rusted in many places
- Wood soffits are exposed and have water damage

Parapet and Fascia Conditions

Removal of the existing roofing assembly is recommended at the gymnasium and over the locker rooms. This will allow for replacement of any damaged roof decking prior to installation of rigid insulation and a single-ply roofing membrane. Replacement of all flashing and soffits, and installation of parapet coping will better protect the building from moisture infiltration.

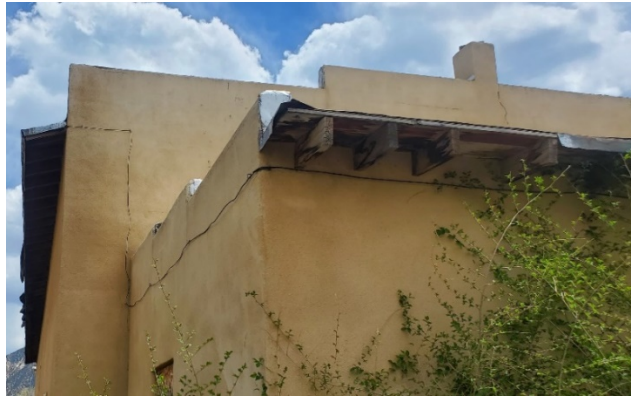
Exposed Framing and Roof Decking

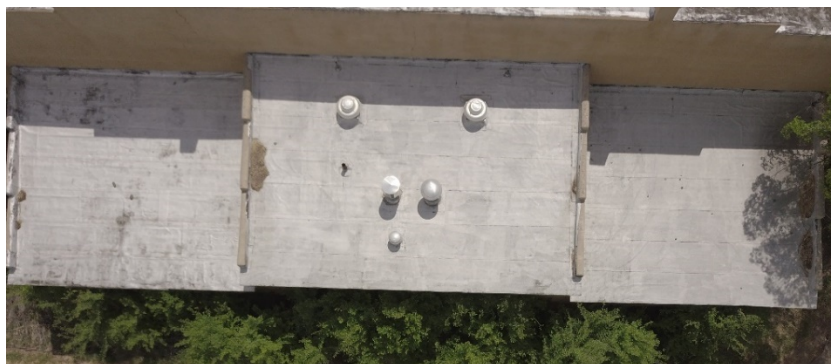
West Roof

The existing roof appears to be a built-up roofing assembly which shows signs of weathering, cracking, and accumulation of dirt. Existing insulation appears to be laid within the plenum above the acoustic ceiling within the gym and northeast small room. There does not appear to be insulation at the roof in other areas of the building, however confirmation of this at rooms with gypsum board ceilings was not possible. Documentation of conditions are based on observations from ground level, interior finish damages from water infiltration, and drone images.

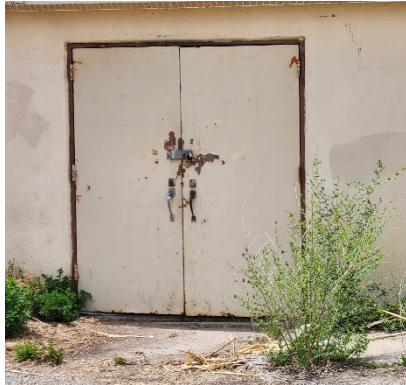
The hollow metal main entry doors are rusted, especially at the door bottoms, and damaged by efforts to secure the facility. The pairs of egress doors from the gymnasium are in similar condition. Also, due to grade change, these doors are located within partially recessed wells filled with debris and do not have railings at the existing retaining walls to protect from falls.

Main Entry Door

It is recommended that all exterior doors, frames, and hardware be replaced in spaces which are to remain. Windows and flashing within the gymnasium should be replaced with thermally broken storefront with low-e coated insulated glazing units.

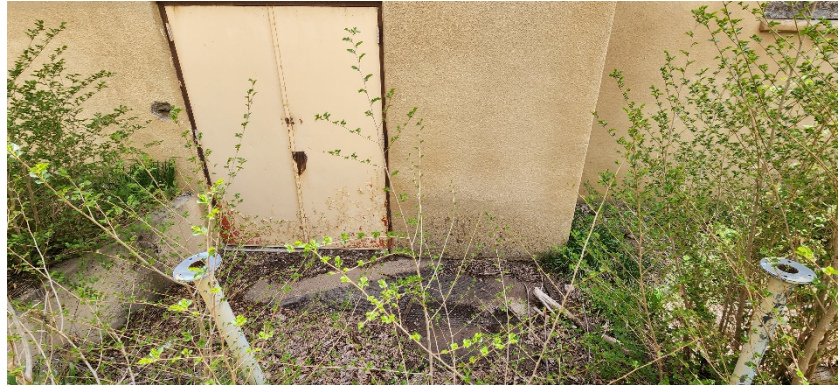
Gymnasium Egress Door

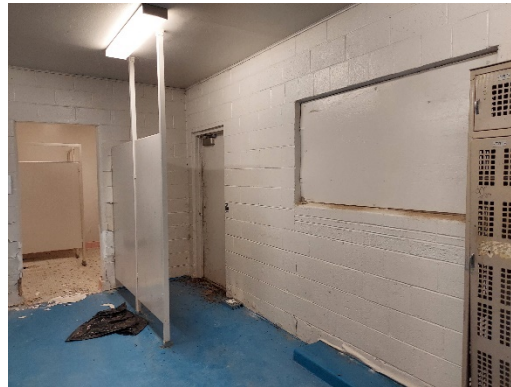
Doors located at the locker rooms are in similarly rusted condition and enter directly into the locker area with a floor and ceiling mounted screen wall partition designed to block the view into the locker room from the exterior.

Locker Egress

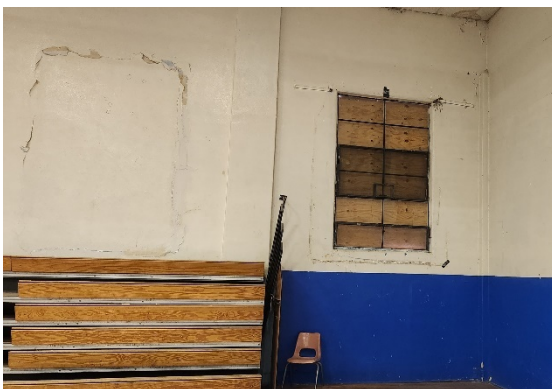
Windows at the gym's north and south elevation are approximately 5' x 8' in size, single pane and each have two operable sections. These windows are in disrepair and provide minimal insulation to protect from heat gain and loss. They are currently boarded over with plywood. There is evidence that several of these windows were removed during the building's lifetime, and the wall repairs show moisture damage at the wall infill's perimeter.

Gym Windows and Previous Window Infill

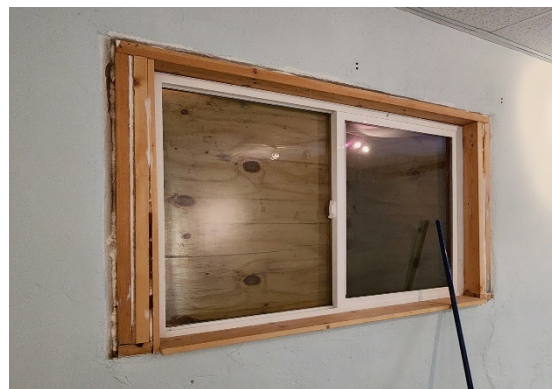
Partially Complete Window Replacement

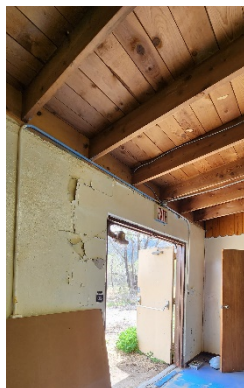
The building interior finishes are generally in poor condition. Walls and ceilings at the building perimeter show water damage, including locations at the entry, northeast ancillary room, mechanical room, and gymnasium. The paint finish is peeling and chipped due to wear and moisture, and areas within the locker rooms and gymnasium have evidence of more severe damage to the CMU block or concrete. Acoustical ceiling systems primarily show damage to the tile panels. There is extensive damage to the walls and ceiling within the men's toilet room and mechanical room with large sections of missing drywall and unfished patching.

Entry Water Damage

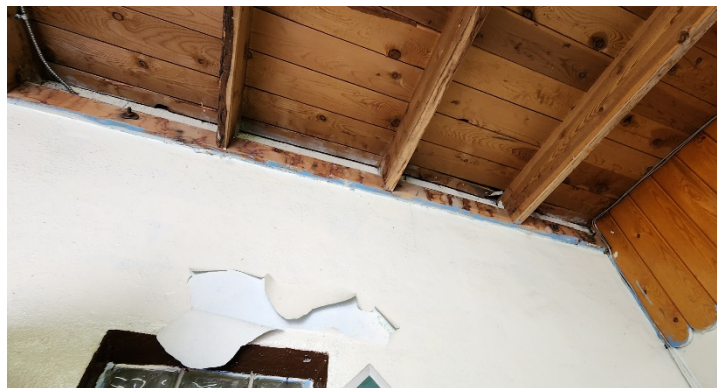
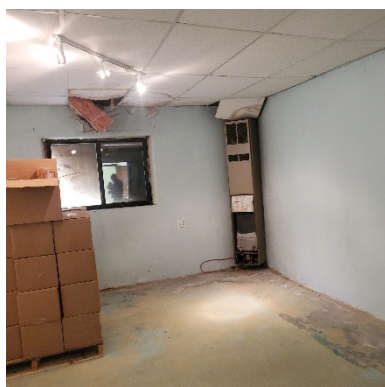
NE Room Ceiling Water Damage

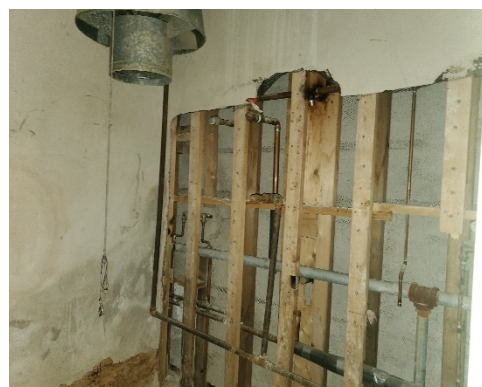
Mechanical Room Walls

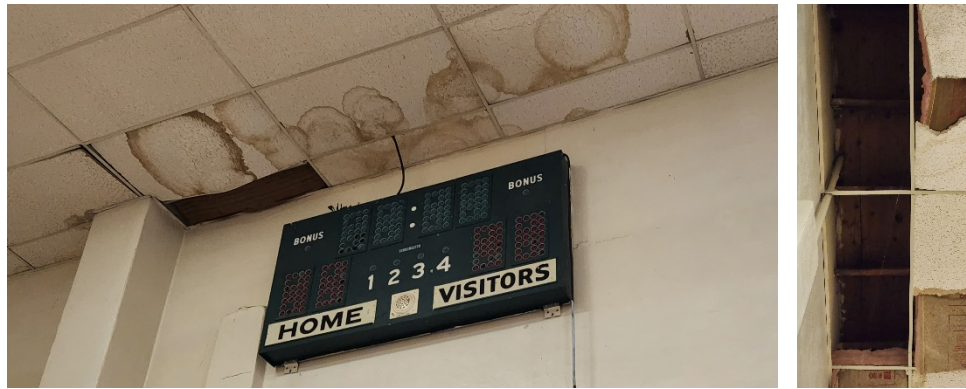
Gymnasium Water Damage

Within the gymnasium it is recommended that the acoustic ceiling system be replaced, all walls be cleaned, patched/repared, and painted. The existing wood flooring system should be removed in its entirety and replaced with a new subfloor and finish supporting the future space use. Prior to installation, the condition of the concrete slab below the gym flooring should be tested for relative humidity levels and moisture content; and, if needed, be sealed or a moisture barrier installed to remove the potential for future damage to installed flooring.

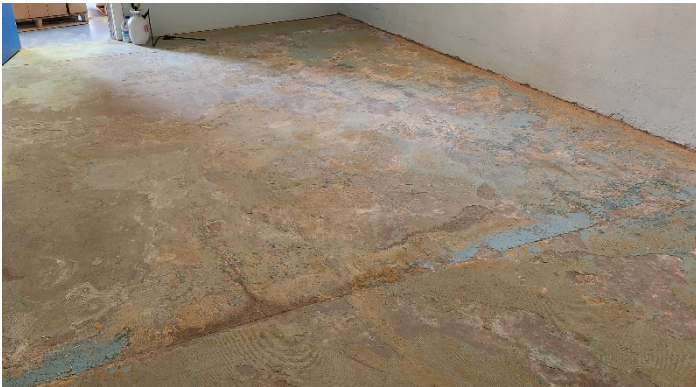
Exposed and painted concrete slabs throughout the facility are chipped, have minor spalling, and are cracked in a few locations.

Room Slab Condition

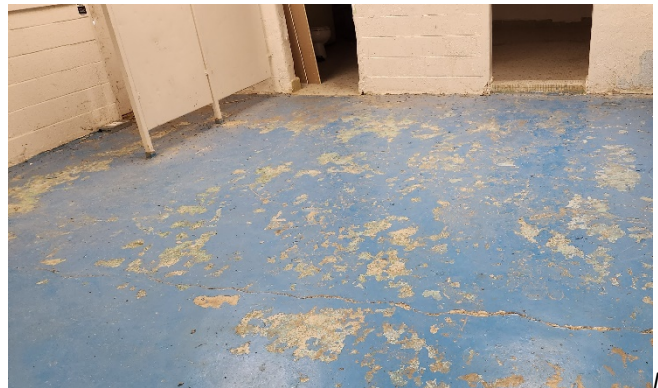
Mens Locker Room Slab Condition

The concrete floors in the locker rooms should be repaired or removed and replaced.

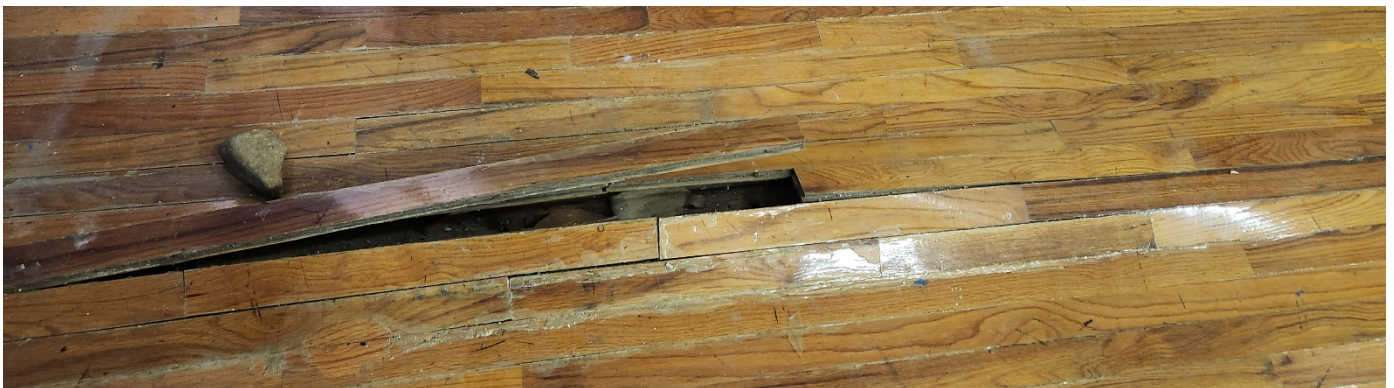
The gymnasium flooring assembly consists of a tongue and groove solid wood finish over top of a raised subfloor. The tongue and groove boards are buckled in several locations across the gymnasium, primarily along the west and east sides of the room. There is evidence this damage is due to moisture within the subfloor or water damage, including observations of a musty damp smell coming from openings within the subfloor and discoloration and peeling of the flooring finish. The seams between boards throughout the space showed signs of cupping which is also indicative of moisture being present below the flooring.

Gymnasium Flooring Damage

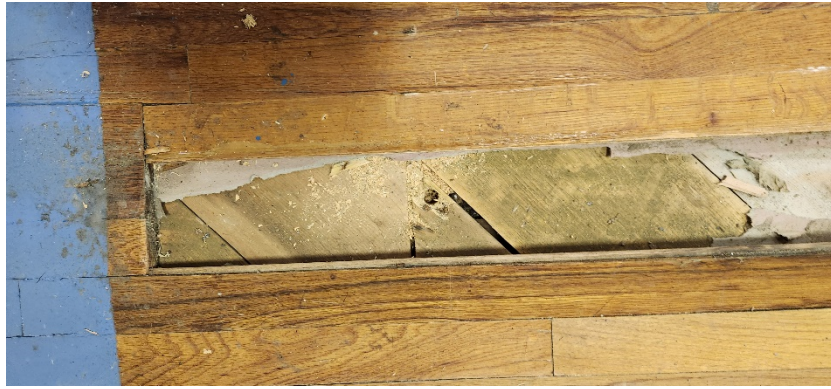
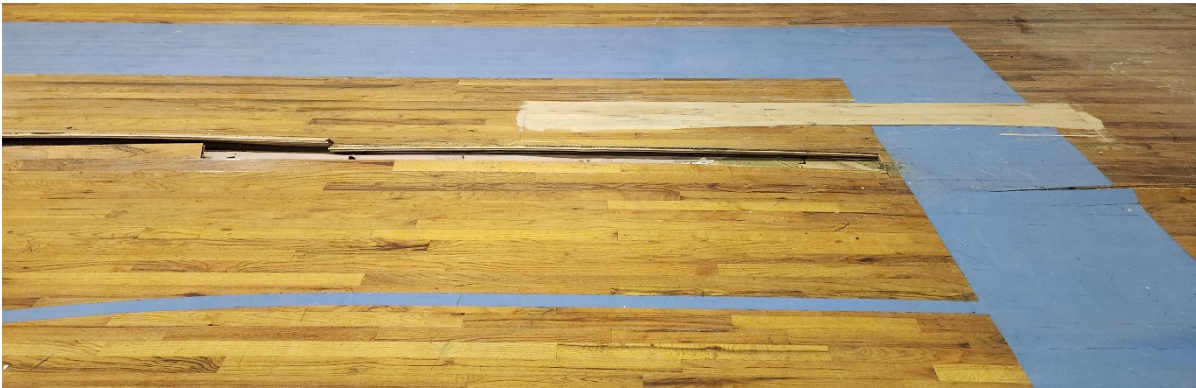
Gymnasium Flooring Damage

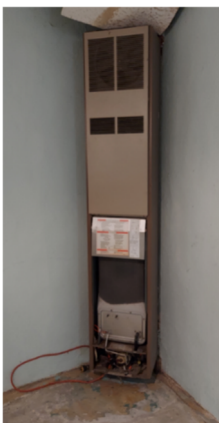
The front ancillary rooms are served by gas fired wall furnaces. The wall furnace in the south room has been removed. The wall furnaces are operated by a thermostat located in each space. Wall furnaces are no longer allowed by code.

Wall Furnace

- Replace HVAC system to provide proper heating, cooling and required ventilation (outside) air required by occupancy type/use.
- Replace exhaust fans and associated ductwork with new for spaces that require exhaust based on occupancy use such as restrooms.

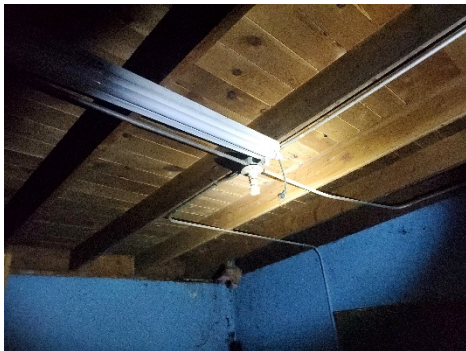
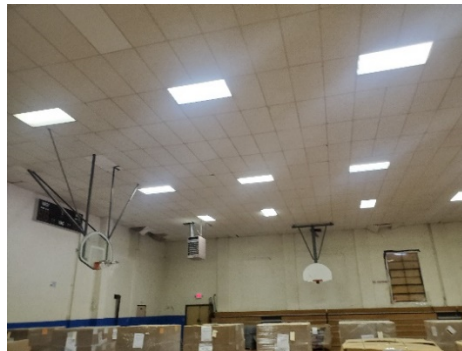
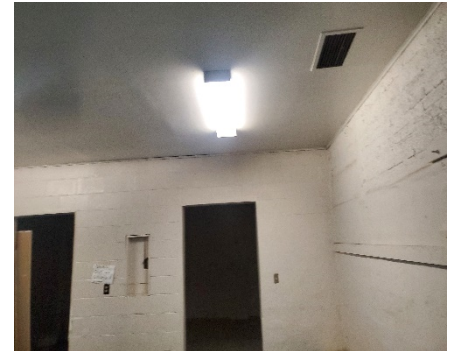
The facility's lighting is made up of T12 high bay fixtures in the main gymnasium, controlled via toggle switches next to the main electrical panel. The gym lighting is old, and the fixture prismatic filters are discolored. The rest of the spaces in the facility are T12 linear fluorescent strip and single bulb ceramic fixtures controlled via toggle switches in each space. The exit lighting is located at each exit in the gymnasium and is served by wall mounted units with attached egress lighting heads. Egress lighting is provided by wall mounted frog eyes located on the exit signs mounted on the walls around the gymnasium. The egress lighting is old and needs to be replaced.

Facility Lighting

- Upgrade electrical service to include a main disconnect and new 200amp, 120/240v, 42 space panelboard.
- Replace lighting throughout with LED fixtures, new lighting controls and occupancy sensor controls as needed throughout the facility.
- Replace the exit and egress lighting with new LED wall mounted fixtures as needed throughout the facility.

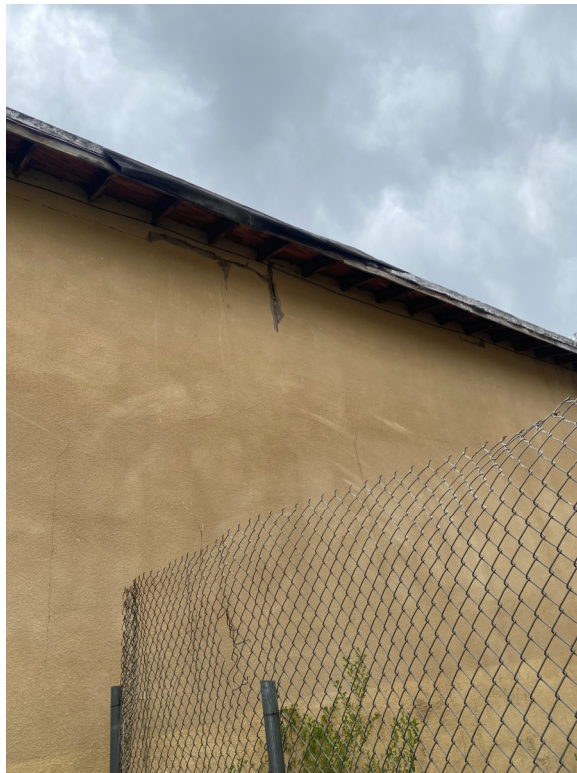
Photo 8 – North- West corner exterior building elevation with exposed soffit and visible cracking

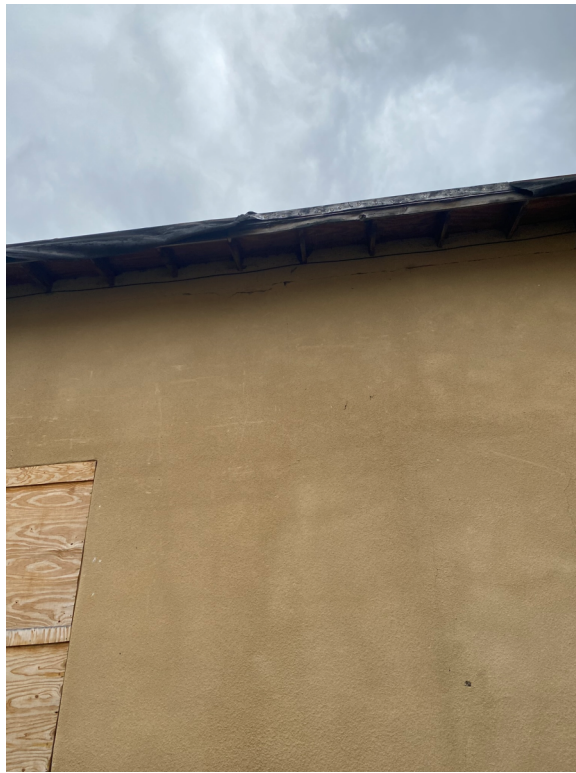
Photo 9 – Exterior building elevation with exposed soffit.

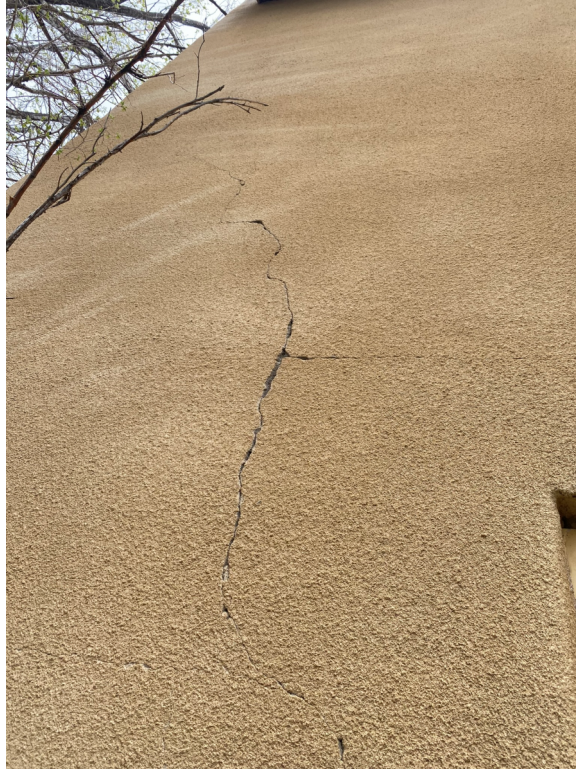
Photo 15 – Exterior wall stucco crack.

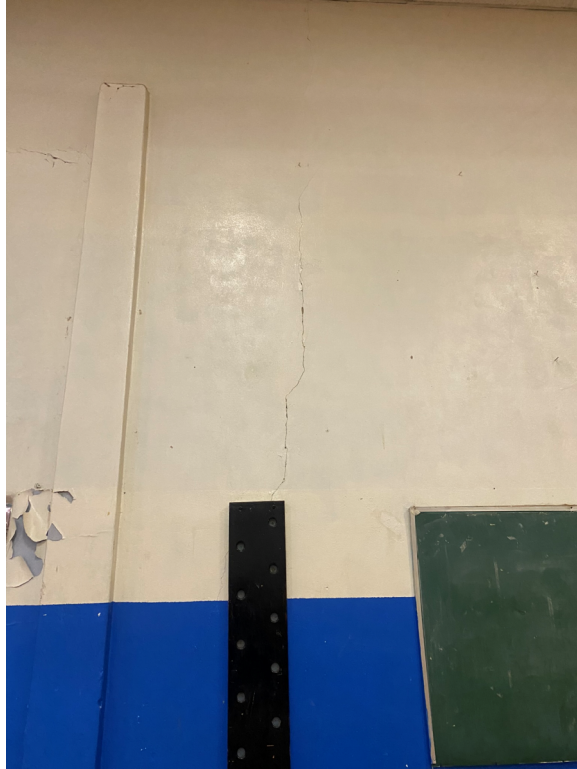
Photo 36 – Gym interior masonry wall cracks above doorway.

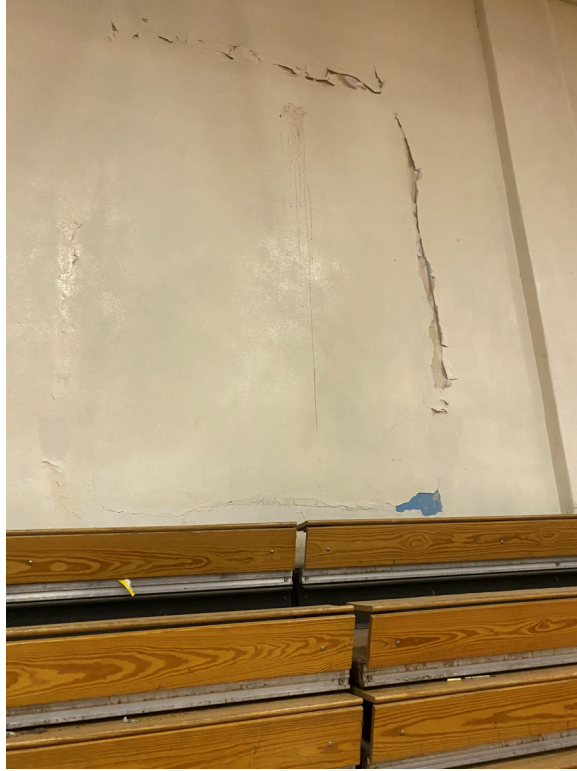
Photo 39 – Gym interior wall crack around previous window opening.

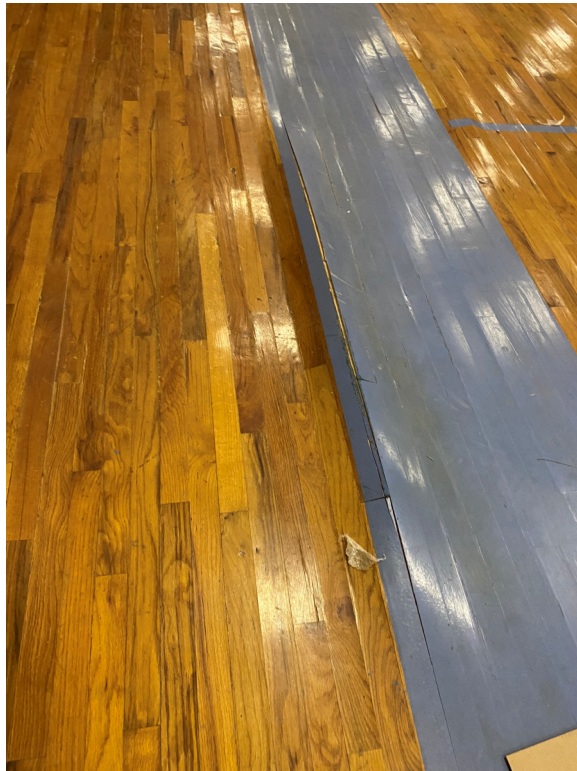
Photo 40 – Gym wood floor planks buckled, warped and uneven.

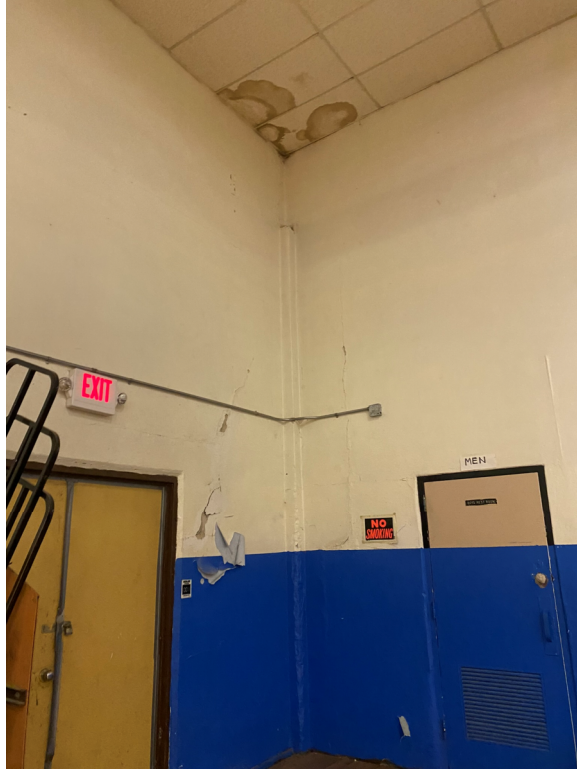
Photo 41 – Gym interior walls and ceiling at corner with visible water stains and cracks.

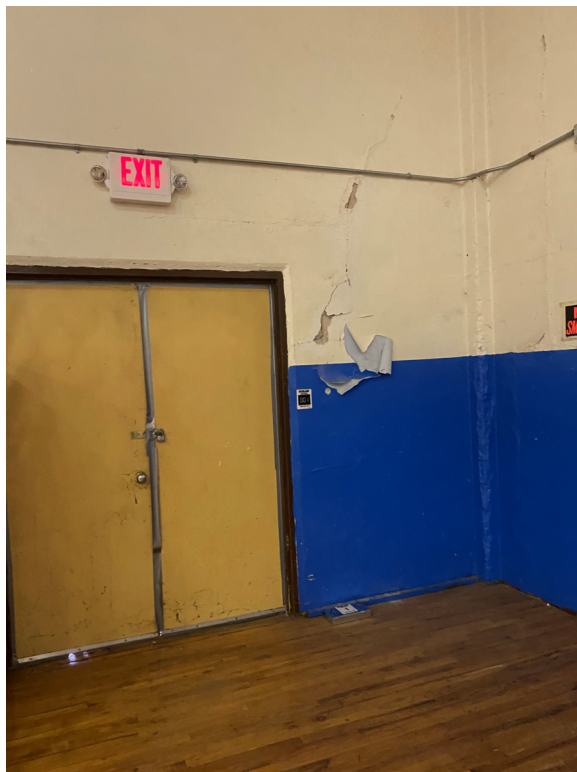
Photo 42 – Gym interior walls and ceiling at corner with visible water stains and cracks at SW corner.

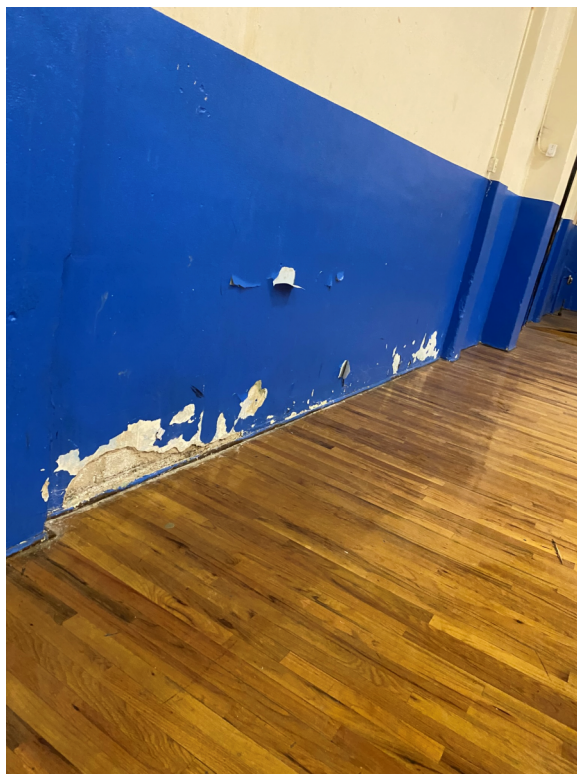
Photo 43 – Gym interior wall at floor with visible moisture damage.

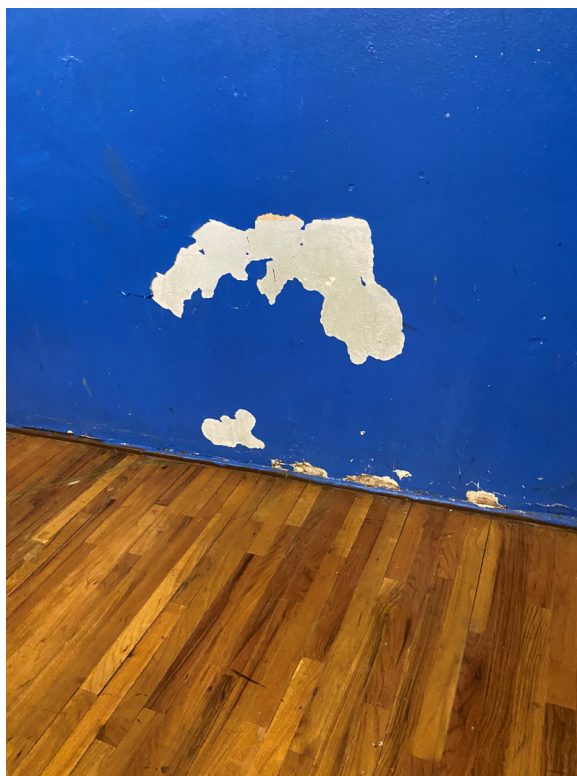
Photo 44 – Gym interior wall at floor with visible moisture damage.

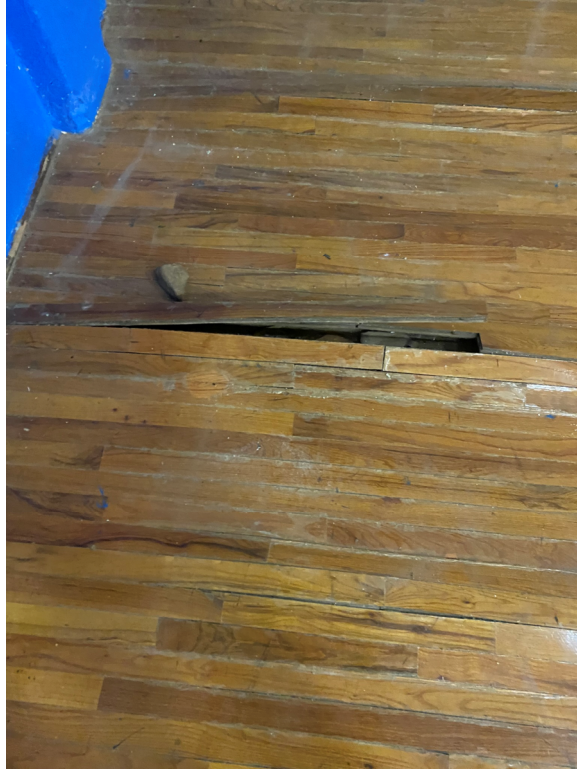
Photo 45 – Gym wood floor plank buckle and separation.

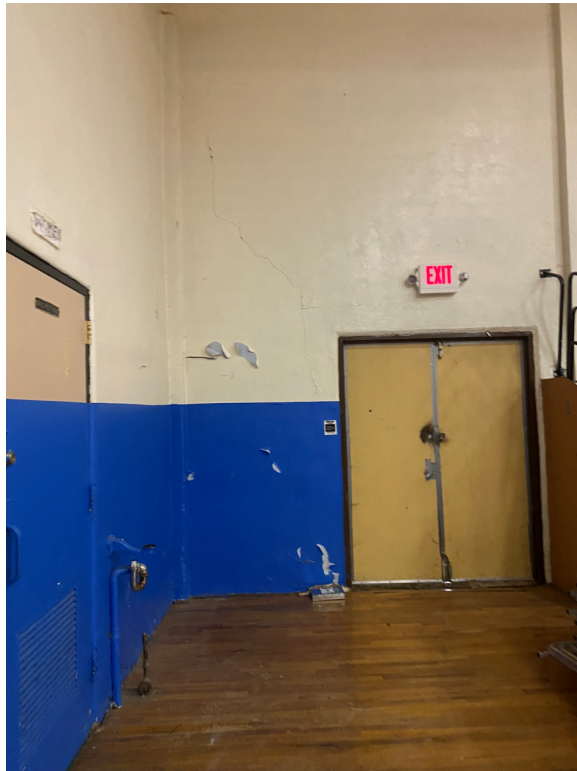
Photo 46 – Gym interior wall at NW door with cracks and visible moisture exposure.

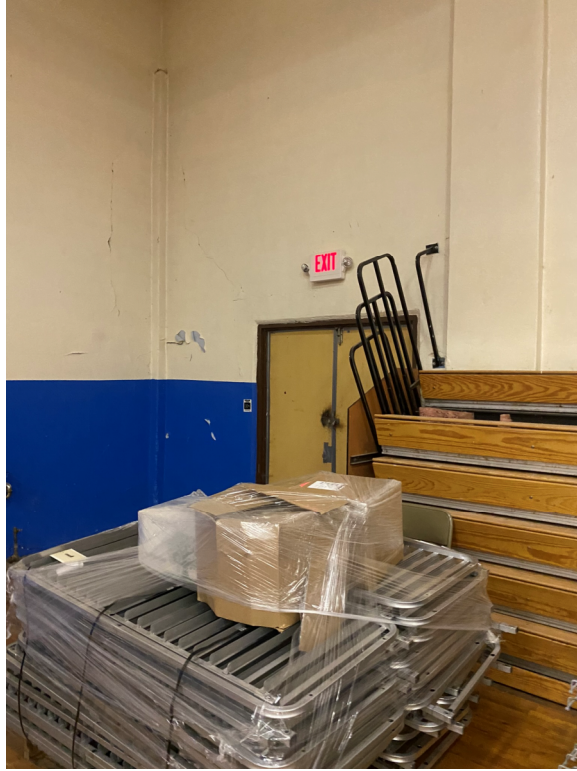
Photo 47 – Gym interior wall at NW corner with cracks.

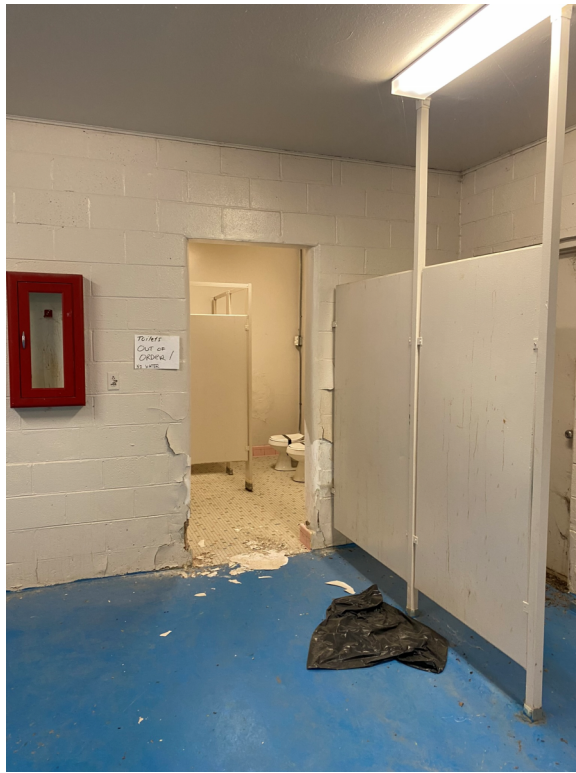
Photo 57 – Gym locker room at bathroom opening with moisture damage.

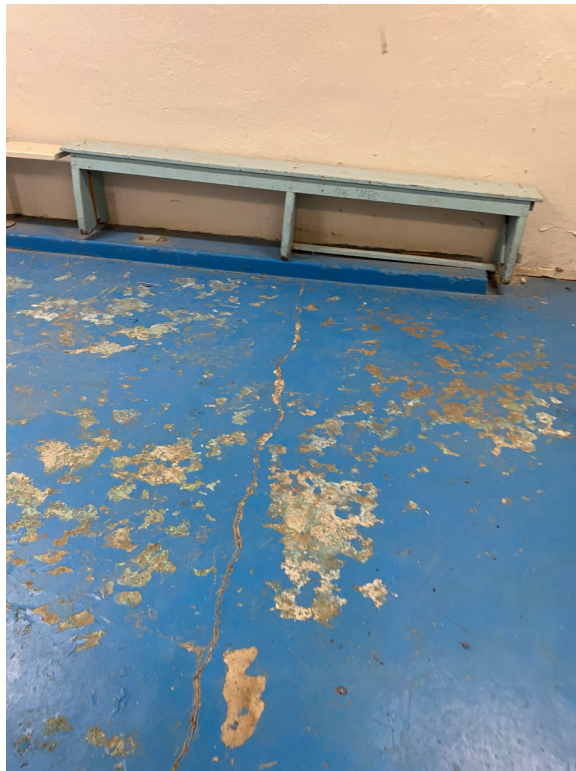
Photo 65 – Gym locker room concrete slab crack.

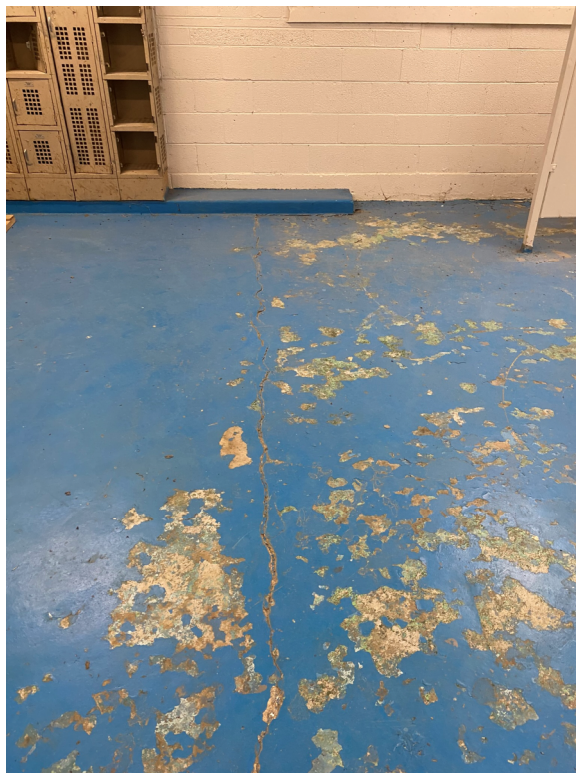
Photo 66 – Gym locker room concrete slab crack.

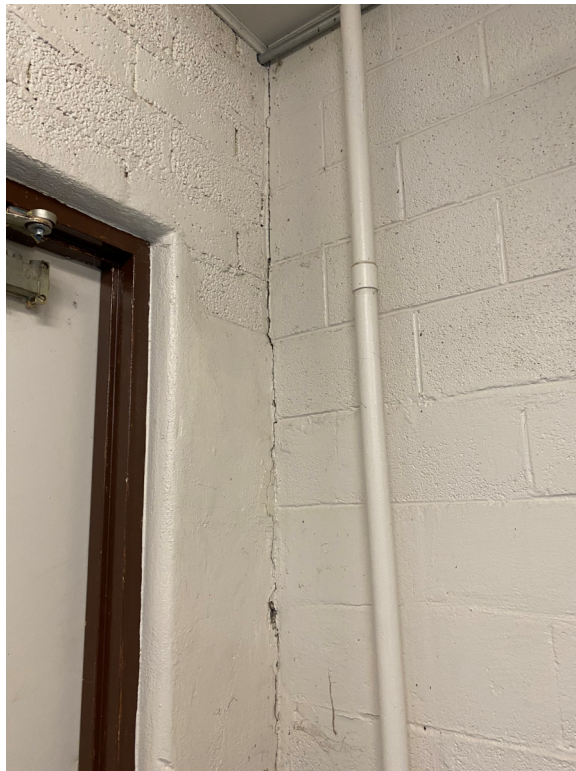
Photo 68 – Gym locker room masonry and brick wall at corner with crack.
