PRE-DEMOLITION ASBESTOS SURVEY

La Cienega School Building
57A Gallegos Rd.
Questa, NM 87556

KEI Job # 234355-1

**Project: Pre-Demolition Asbestos Survey
La Cienega School Building
57A Gallegos Rd.
Questa, NM 87556
KEI Job # 234355-1**

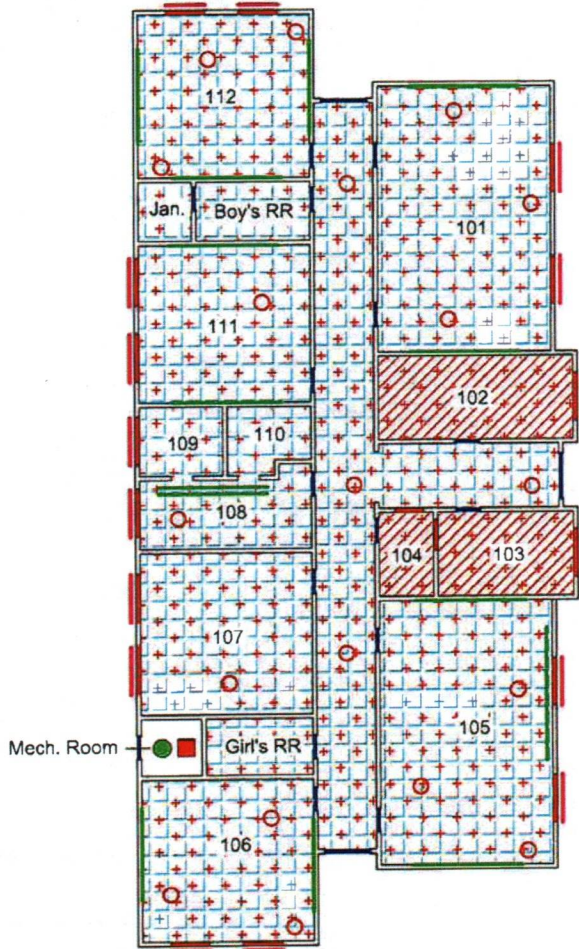
DESCRIPTION	Asbestos
	SCALE	AS NOTED
	SHEET	1 OF 1

Asbestos Containing Materials	
	Floor Tile Under Carpet
	Boiler Unit Door Insulation
	Pipe Fitting Insulation
	2' x 4' Ceiling Panels
	Transite Chalkboard
	12" Blue Floor Tile
	Interior Door Caulking
	Exterior Window Glazing
	Interior Window Caulking
	Gray Weathered Roof Penetration Sealant throughout Roof Top

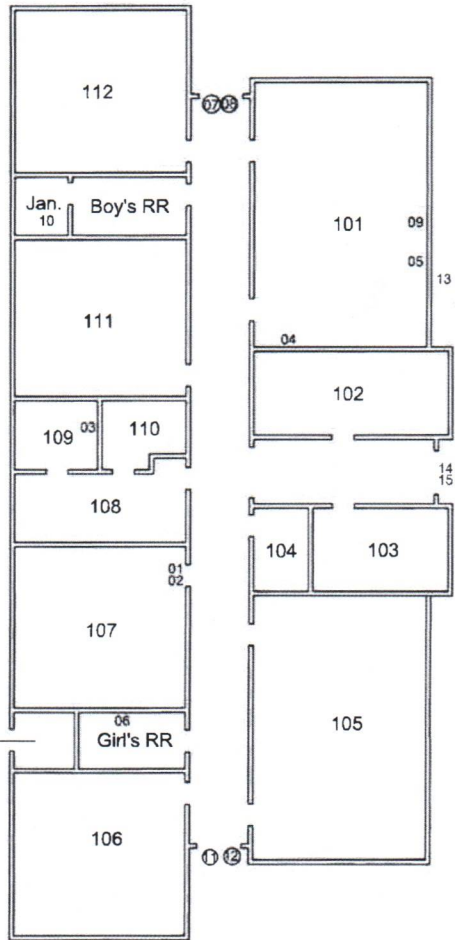
Lead Survey

Sample No.	Test Locations*	Color	Substrate	Result	Condition
LBP-7	CORRIDOR NORTH EXIT DOOR	BROWN	METAL	1.9	POOR
LBP-8	CORRIDOR NORTH EXIT DOOR FRAME	BROWN	WOOD	1.6	POOR

Sample No.	Test Locations*	Color	Substrate	Result	Condition
LBP-11	SOUTH SIDE DOOR	BROWN	METAL	4.3	POOR
LBP-12	SOUTH SIDE DOOR FRAME	BROWN	WOOD	1.2	POOR

***Please note that the brown door and door frame components were observed on doors and door frames leading to the exterior. Approximately four door areas to the outside of the building were observed.**
