Village of Questa

Facility Assessment Report La Cienega Gymnasium

Questa, NM

Date: September 18, 2023

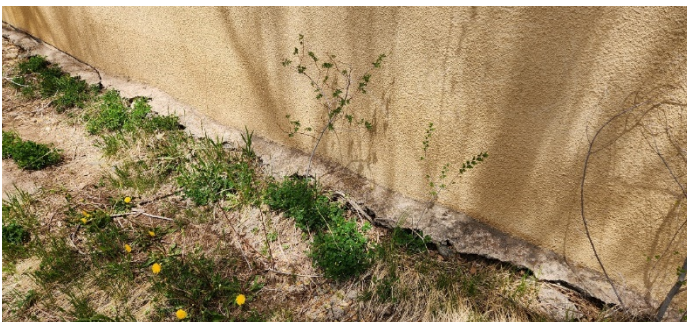
Overall, the grading around the building is relatively flat and storm water from the roof sits adjacent to the building and infiltrates into the soils or evaporates. There are no signs of structural issues on the foundation caused by the lack of positive flow of storm water away from the building.

Stucco at base of building

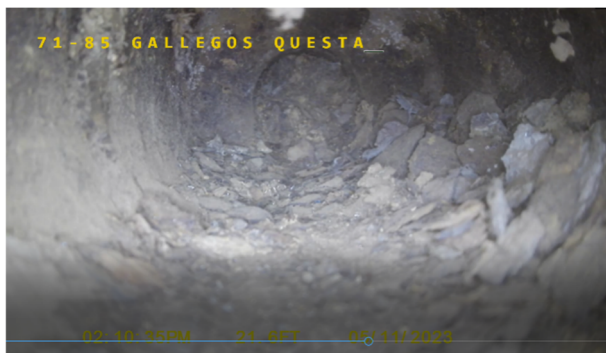
The existing 4 inch sanitary sewer enters the building at the southwest corner. There is a double cleanout to grade between the building and road. Sewer piping is cast iron below grade. The sewer line was scoped and videoed by TLC Plumbing and appears to be very old and slightly filled with debris. From the video it appeared that the service line terminates at an existing septic tank has been filled with soil and abandoned in place. Based on the site visit, it is uncertain where the existing leach field is for the site; and currently, there is not a sewer main in the area, but one is planned for in the future though maybe too far from the building to connect to. The termination of the sewer service into the filled septic tank is shown in the photo below.

Blocked Sanitary Sewer

- Replace all interior plumbing piping, fixtures and domestic water heater for new accessible layout and any additional fixtures. Piping to be replaced back to main pipe entrance.
- Install required floor drains/floor sinks as required by Code.
- Replace septic system and leach field for service of new layout and additional fixtures.
- Replace gas piping for new HVAC system and domestic water heater.

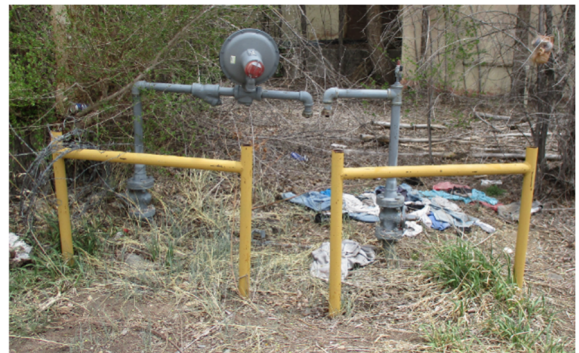
The natural gas service is located northwest of the building. There is a medium pressure line (2 PSI) routed to the building with a pressure regulator at the building to reduce pressure. A 2-½ inch low-pressure natural gas line enters the mechanical room from the west. There is an underground 1" underground natural gas service with regulator in place. The service has been disconnected but appears to be in good shape, as shown in photo below.

Natural Gas Service

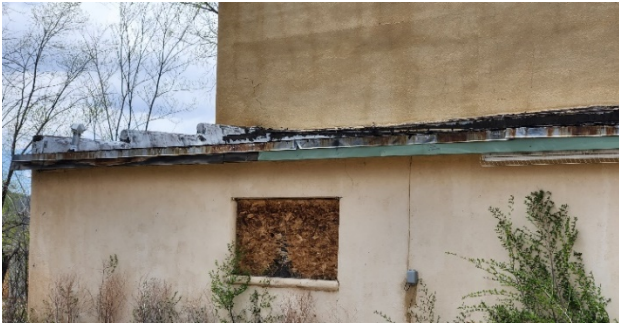
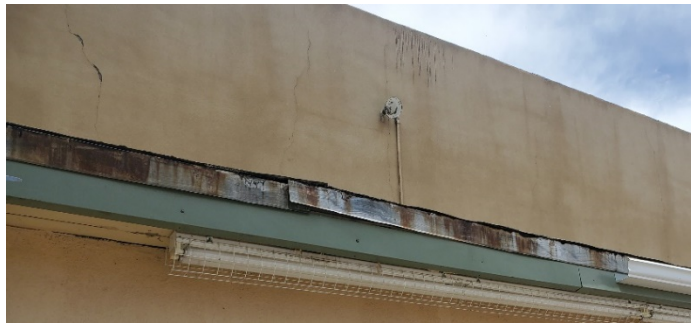
- Roofing shows evidence of patching/repair at termination bars, parapets, and built-up roofing
- Metal fascia and flashing is in disrepair and is rusted in many places
- Wood soffits are exposed and have water damage

Fascia and Drip Edge Flashing, Parapet Patching

Removal of the existing roofing assembly is recommended at the gymnasium and over the locker rooms. This will allow for replacement of any damaged roof decking prior to installation of rigid insulation and a single-ply roofing membrane. Replacement of all flashing and soffits, and installation of parapet coping will better protect the building from moisture infiltration.

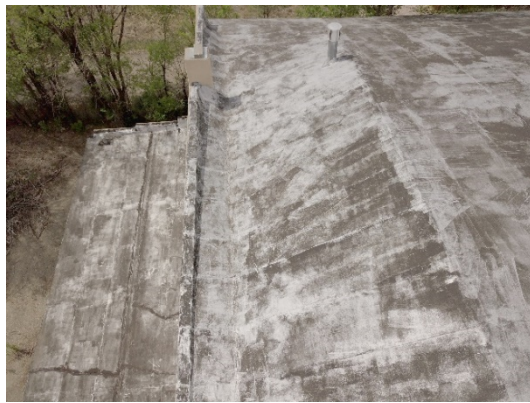
The existing roof appears to be a built-up roofing assembly which shows signs of weathering, cracking, and accumulation of dirt. Existing insulation appears to be laid within the plenum above the acoustic ceiling within the gym and northeast small room. There does not appear to be insulation at the roof in other areas of the building, however confirmation of this at rooms with gypsum board ceilings was not possible. Documentation of conditions are based on observations from ground level, interior finish damages from water infiltration, and drone images.

Gymnasium Roof

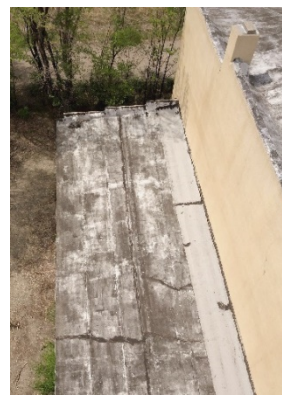
East Roof

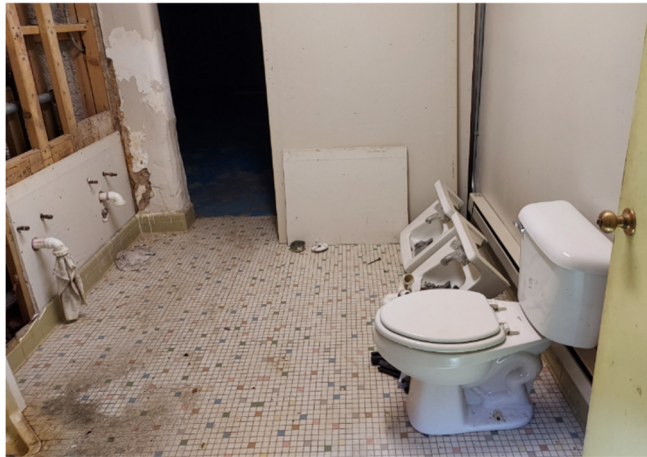
Plumbing fixtures include wall hung vitreous china lavatories, floor mount tank type water closets, a floor mount urinal, and chrome plated shower trim packages. The showers have two handles without pressure/temperature balance mixing valves. Most of the fixtures have been removed. Floor mounted urinals are no longer allowed by code and none of the fixtures are water savings models.

Removed Plumbing Fixtures

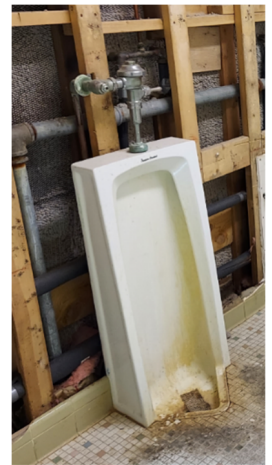
Floor Mount Urinal

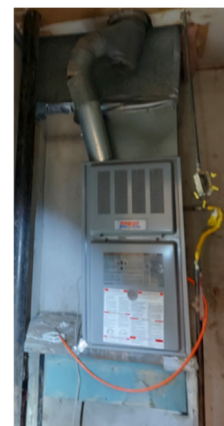
The locker rooms, restrooms and shower areas are served by a residential type gas fired furnace located in the mechanical room. The furnace is operated by a thermostat located in the mechanical room. It was observed there are no return air grilles for air path back to furnace in mechanical room.

Furnace

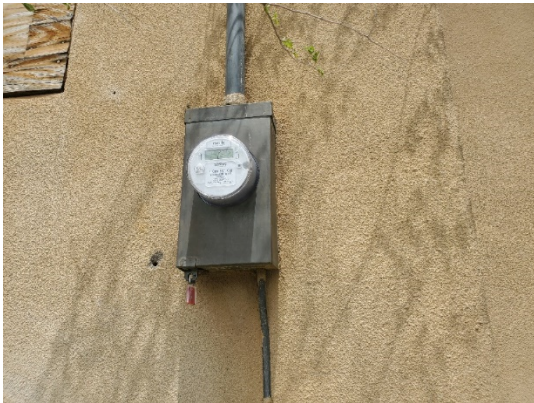
Service Meter

The building electrical service is provided by Kit Carson Electrical Coop via an overhead line extending from a power pole to a weather head mounted onto the building. A 2 inch conduit extends from the weather head to a surface mounted meter enclosure.

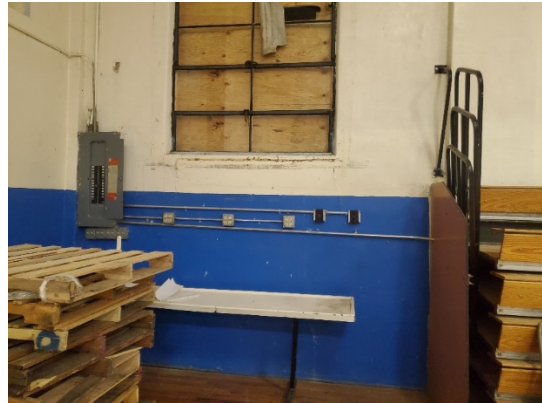
Main Panelboard

The main electrical panel is a 200amp, 120/240v, 1ph, 3 wire system, 30 space panelboard. There is no main breaker on the panel or on the building, therefore the electrical service does meet the current NEC code.

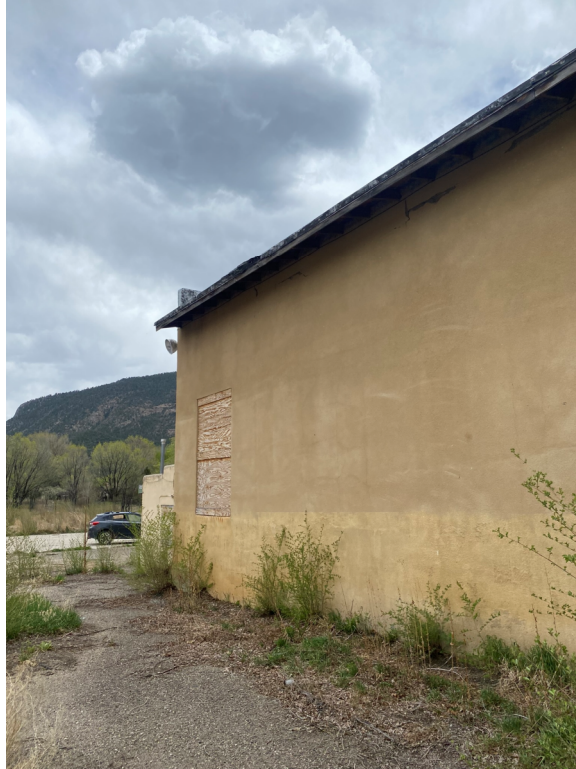
There is extensive overgrowth of vegetation at the building exterior including tree/shrub growth adjacent to the building foundation at all elevations.

Photo 11 – Northeast exterior building elevation and vegetation.

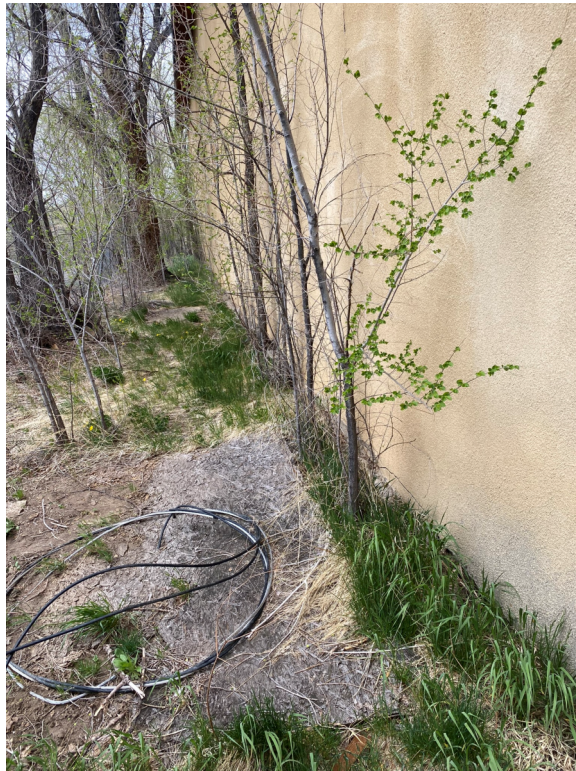
11. There is heavy and very close vegetation in the way of shrubs and trees along the south, west and north sides of the building.
12. There are areas of minor wood drying and potential dry rot along the north and south roof soffits.

Photo 12 – South exterior building elevation and vegetation.

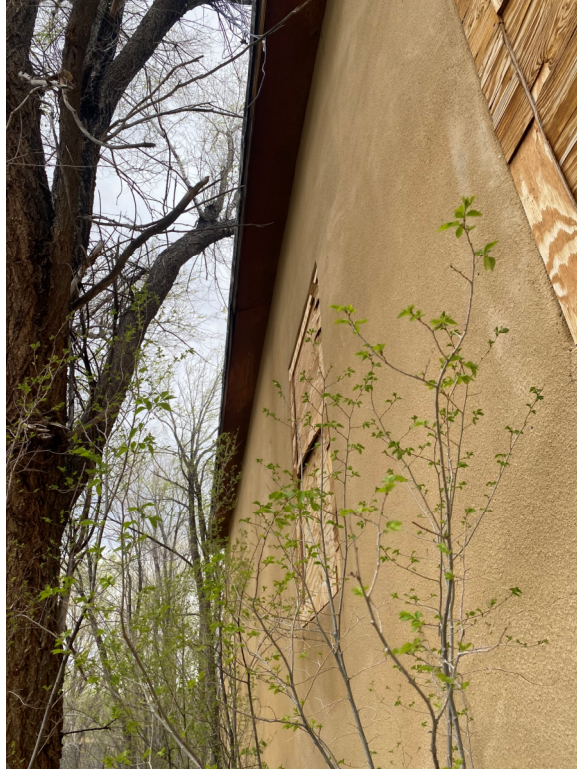
Photo 13 – South exterior building elevation and vegetation.

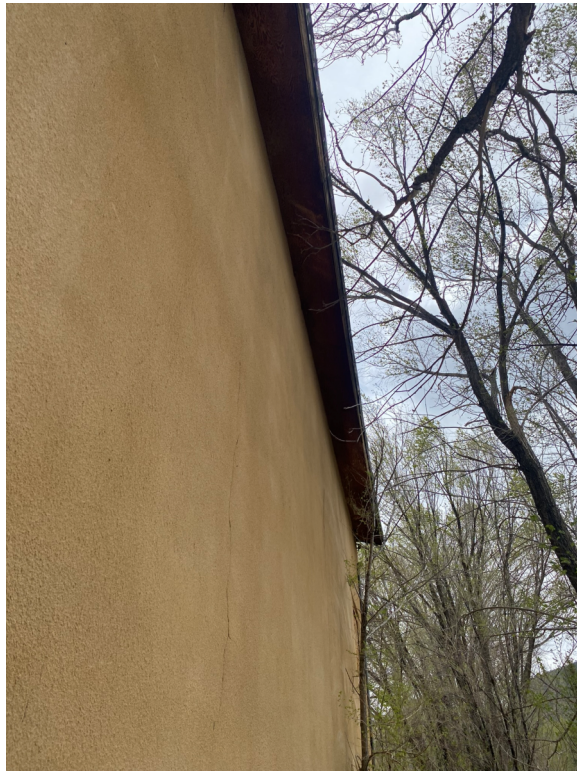
Photo 14 – Exterior building elevation and vegetation.

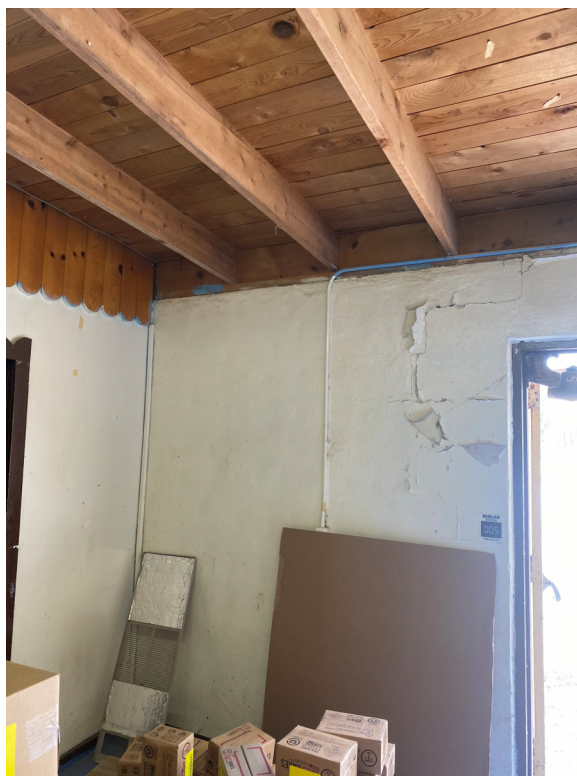
Photo 26 – East entry roof framing

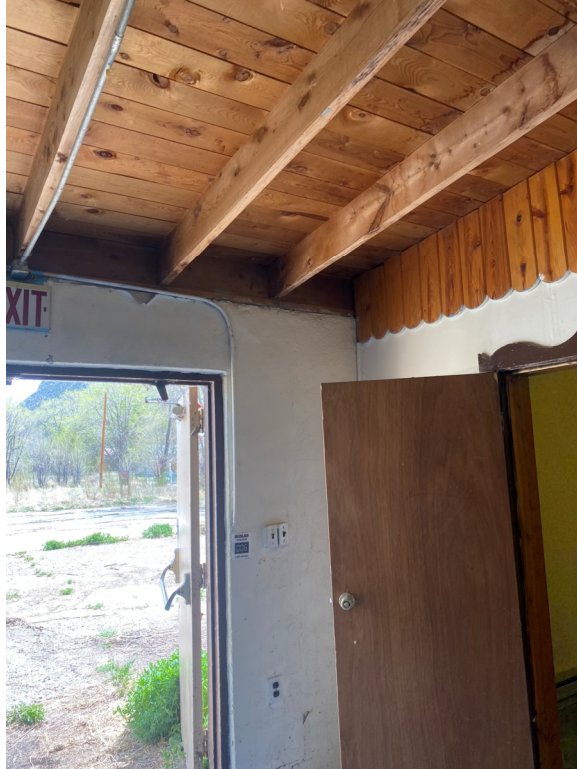
Photo 27 – East entry roof framing.

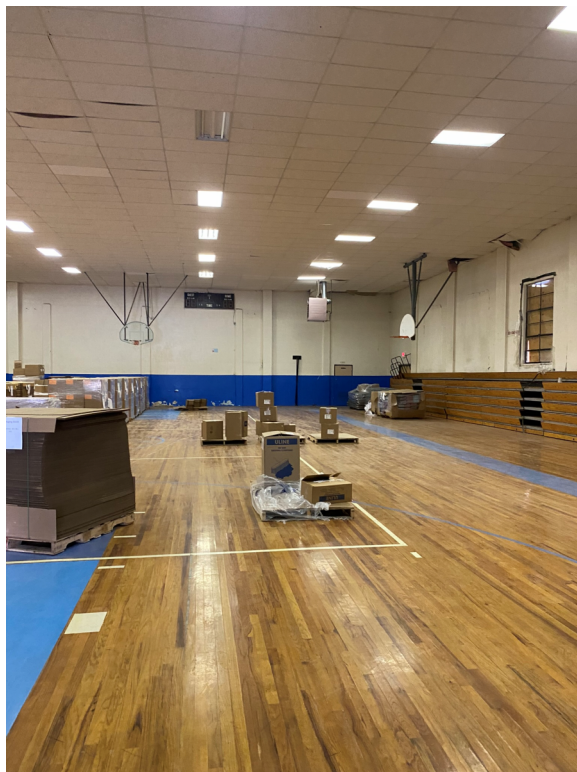
Photo 28 – Gym interior

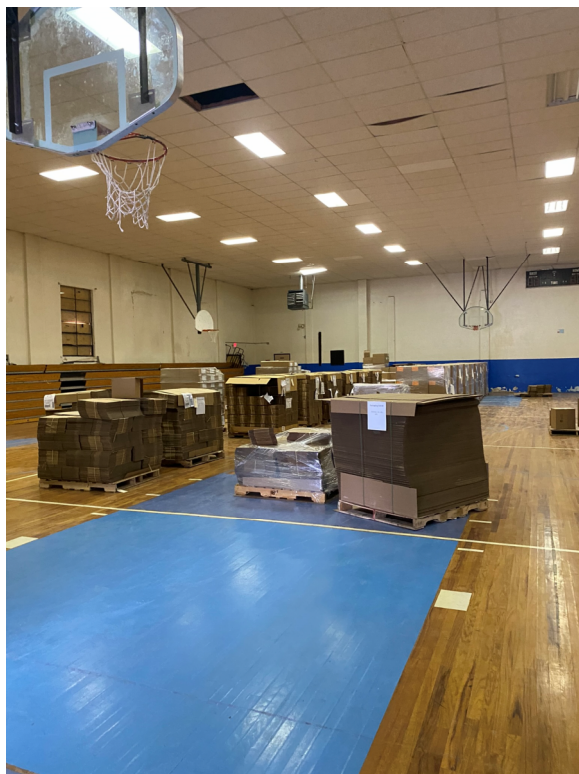
Photo 29 – Gym interior

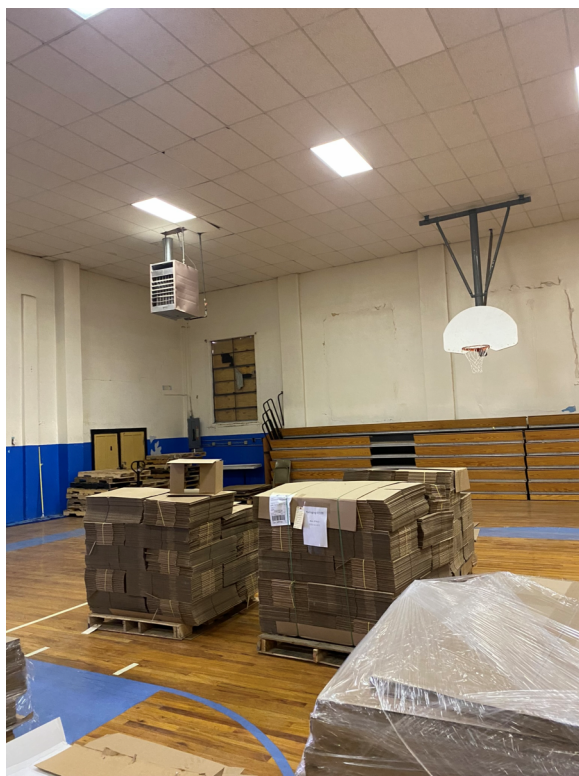
Photo 30 – Gym interior

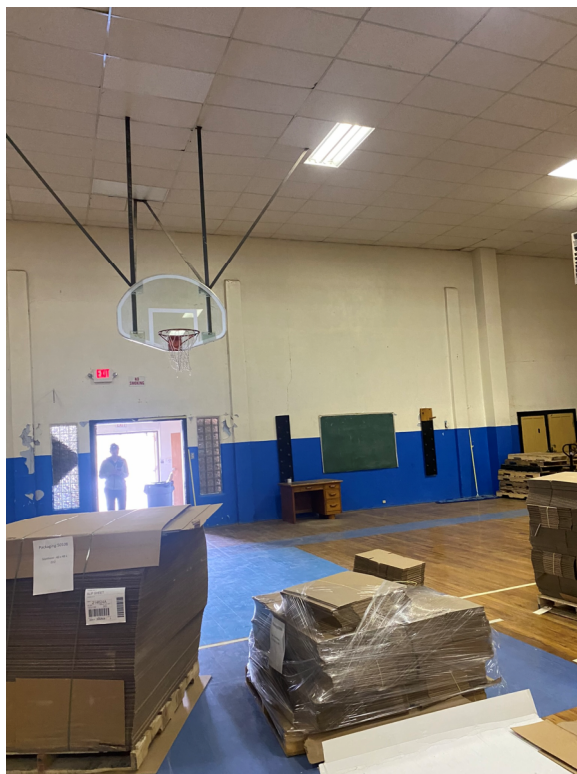
Photo 31 – Gym interior

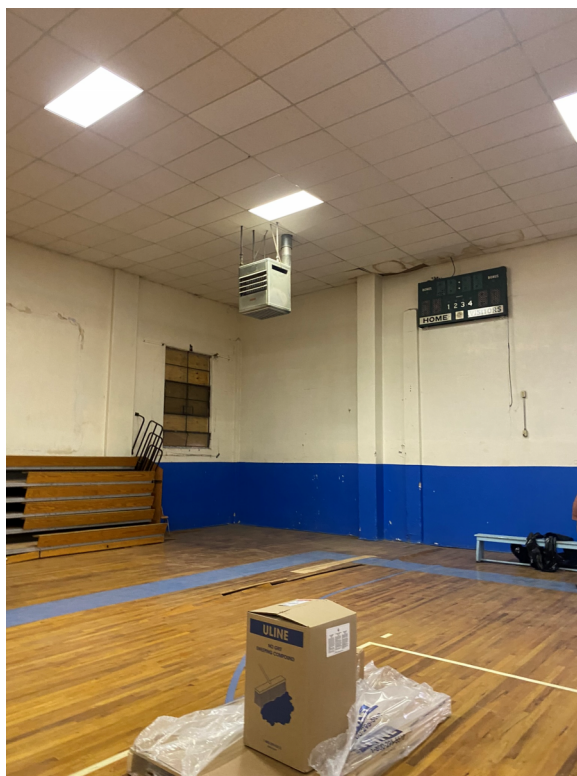
Photo 32 – Gym interior

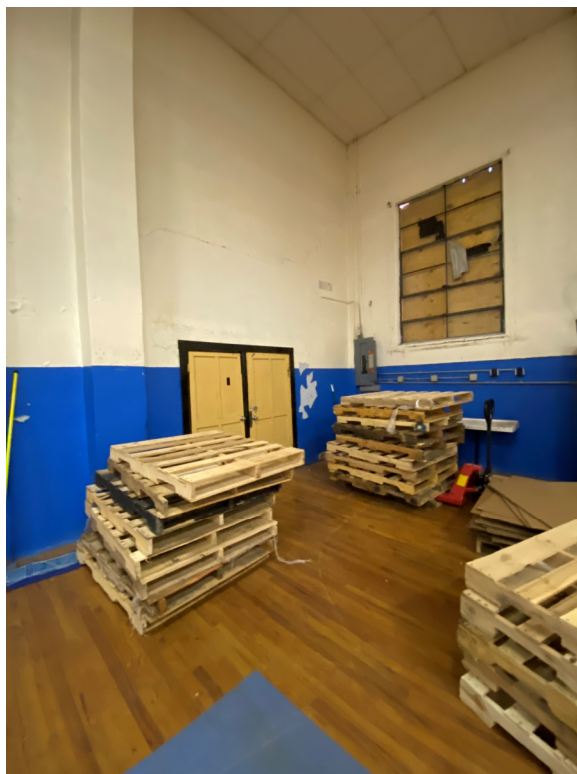
Photo 35 – SE Gym interior, cracks on interior masonry wall

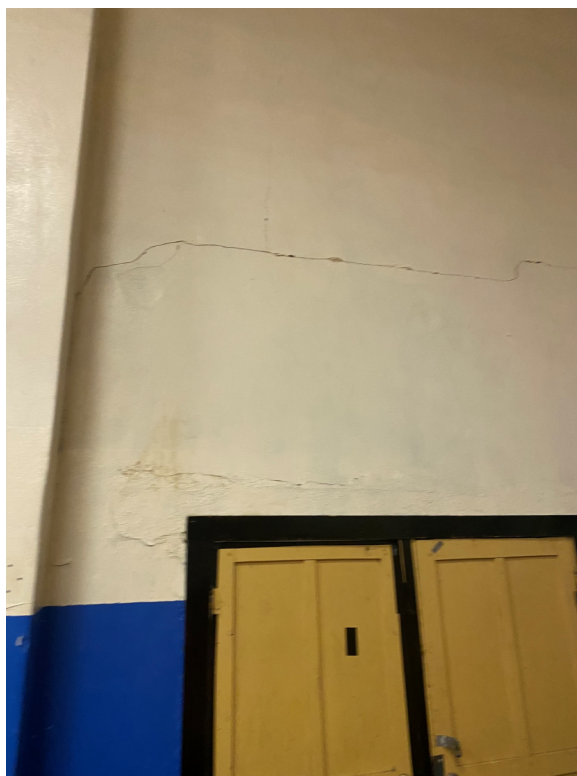
Photo 36 – Gym interior masonry wall cracks above doorway.

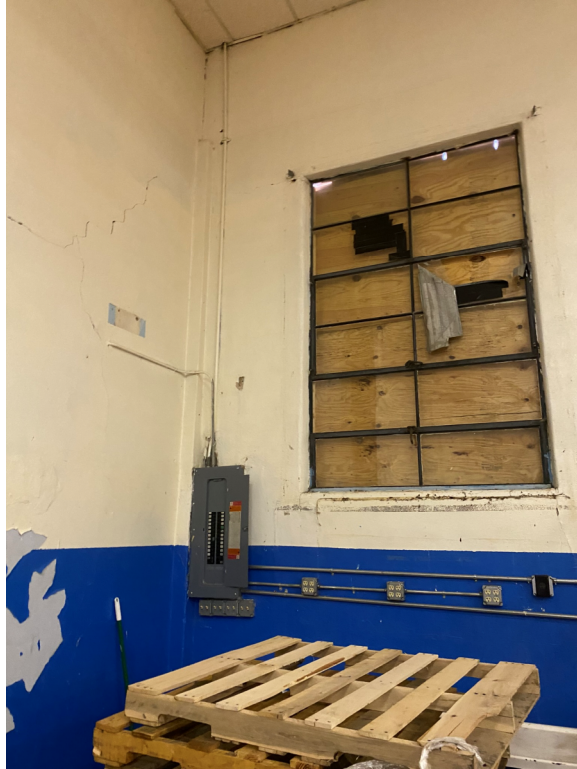
Photo 37 – Gym interior wall with boarded up window.

It is recommended that all exterior doors, frames, and hardware be replaced in spaces which are to remain. Windows and flashing within the gymnasium should be replaced with thermally broken storefront with low-e coated insulated glazing units.

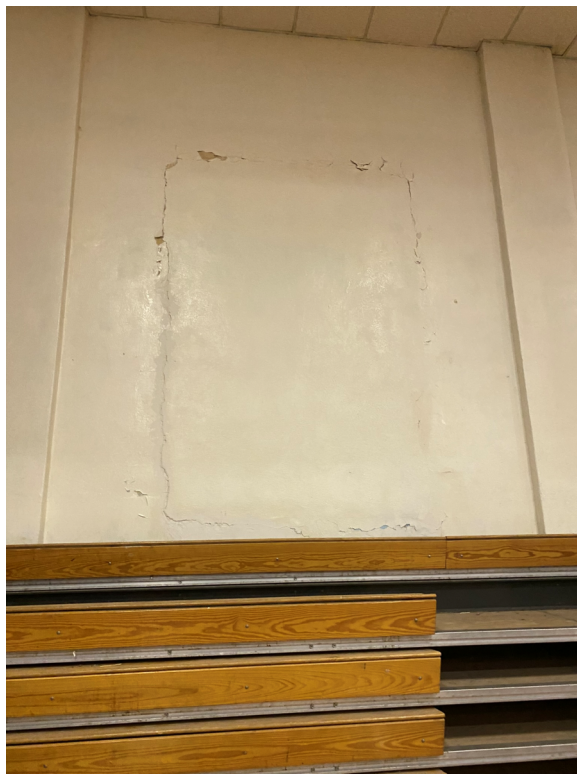
Photo 38 – Gym interior wall crack around previous window opening.

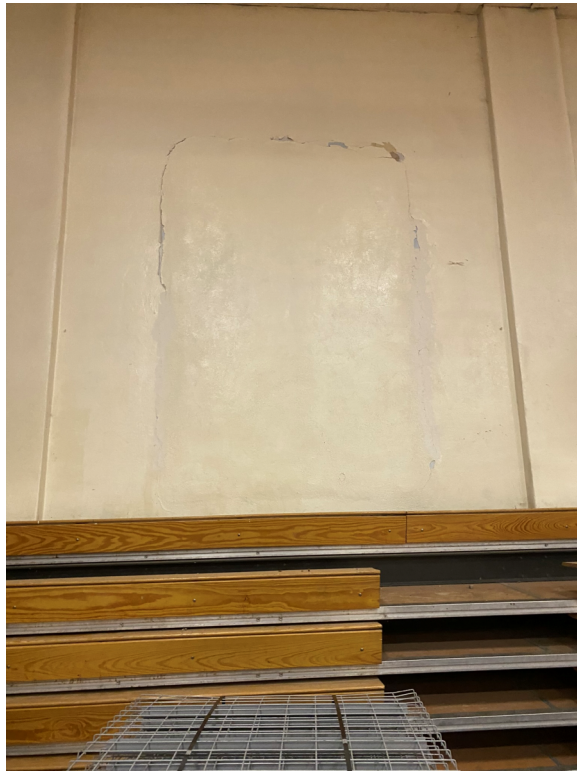
Photo 48 – Gym interior north wall with infilled opening.

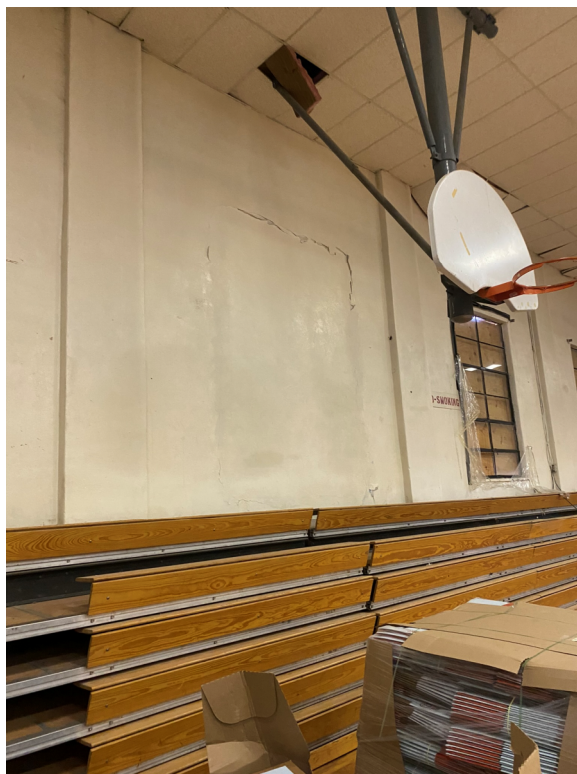
Photo 49 – Gym interior north wall at with infilled opening.

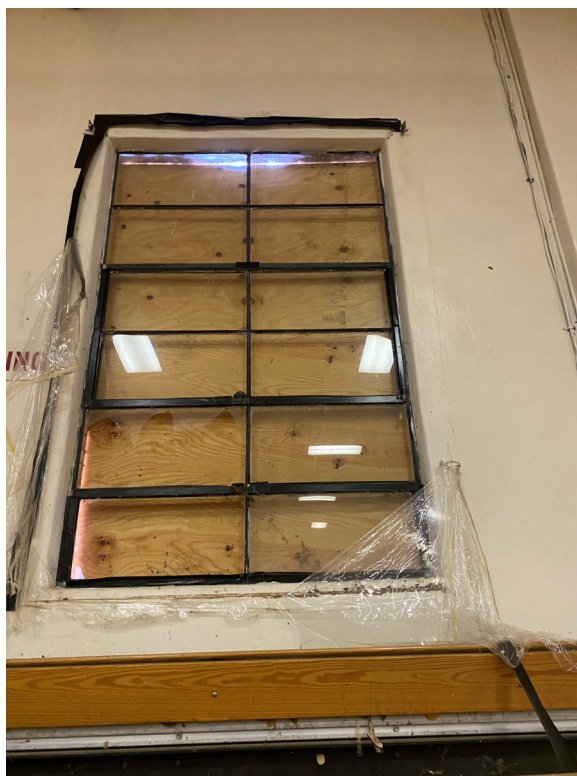
Photo 50 – Gym interior north wall with infilled window.

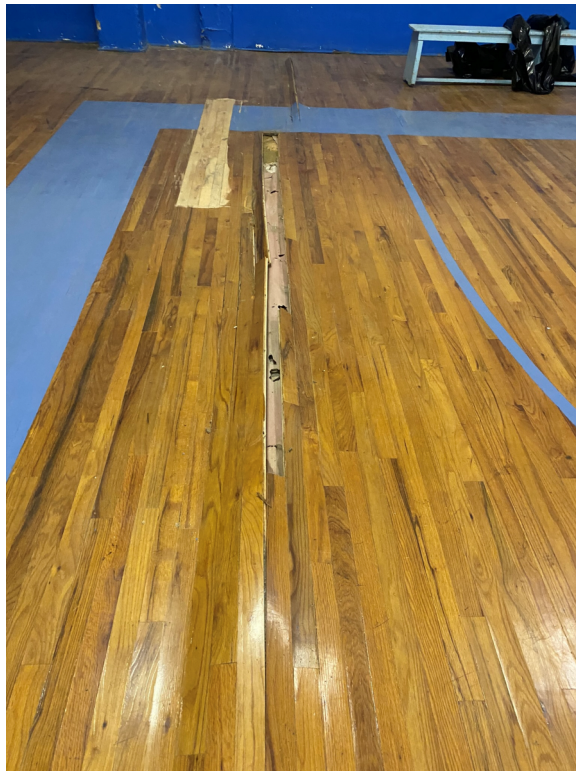
Photo 51 – Gym floor separation and buckling.

Within the gymnasium it is recommended that the acoustic ceiling system be replaced, all walls be cleaned, patched/repared, and painted. The existing wood flooring system should be removed in its entirety and replaced with a new subfloor and finish supporting the future space use. Prior to installation, the condition of the concrete slab below the gym flooring should be tested for relative humidity levels and moisture content; and, if needed, be sealed or a moisture barrier installed to remove the potential for future damage to installed flooring.

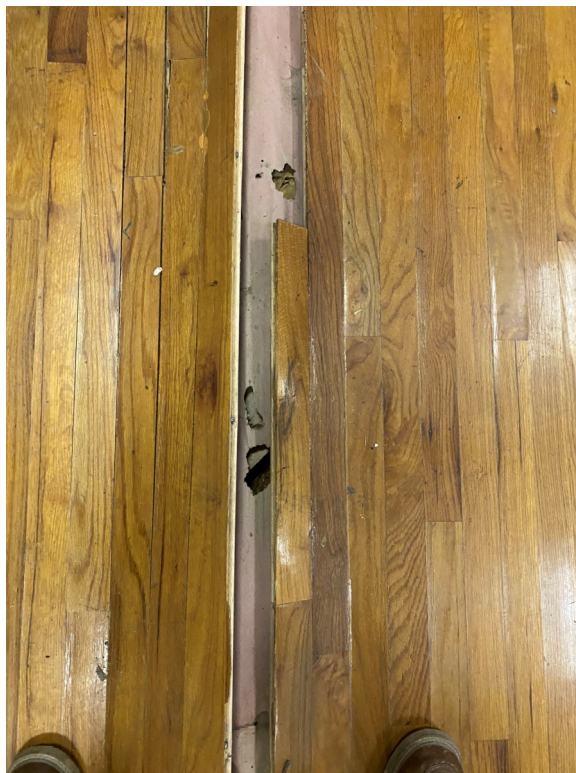
Photo 52 – Gym floor buckle and separation close-up view.

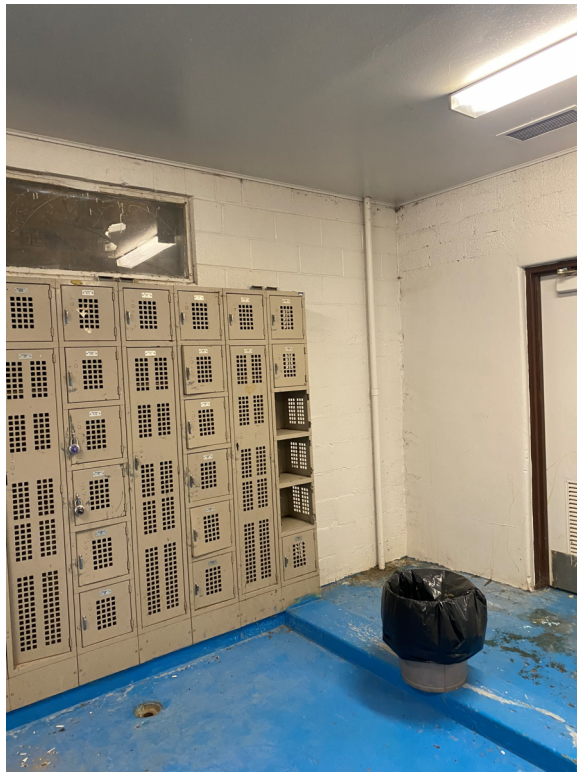
Photo 53 – Gym locker room corner at masonry wall.

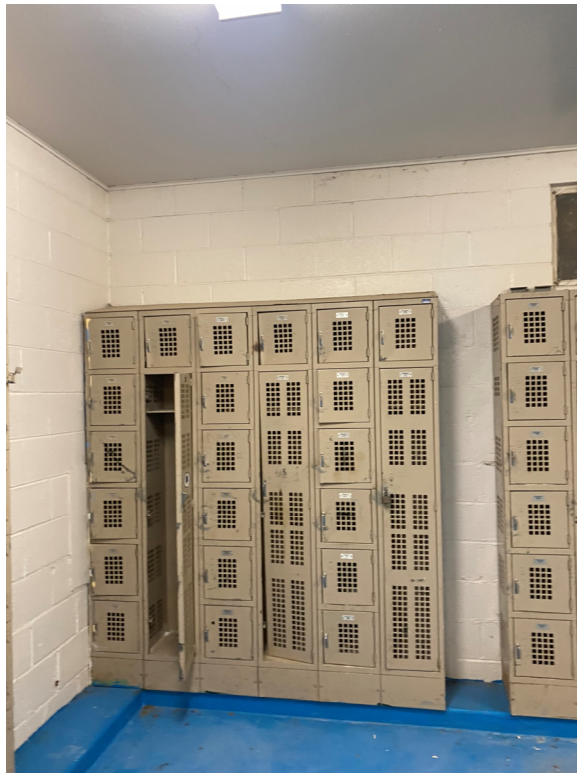
Photo 54 – Gym interior wall in locker room.

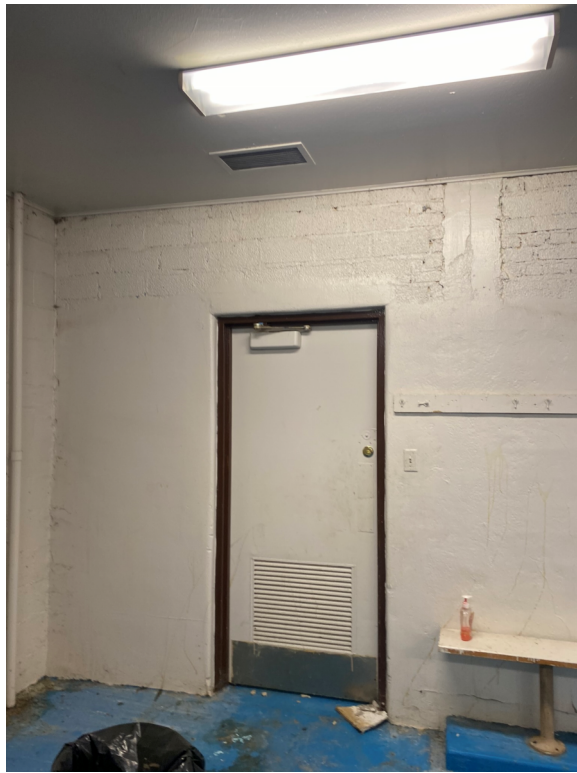
Photo 55 – Gym interior masonry and brick wall at opening.

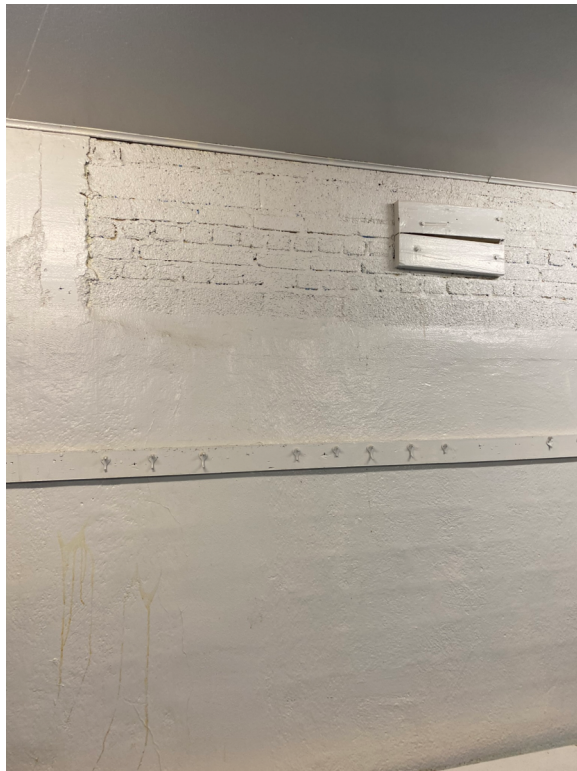
Photo 56 – Gym interior masonry and brick wall.

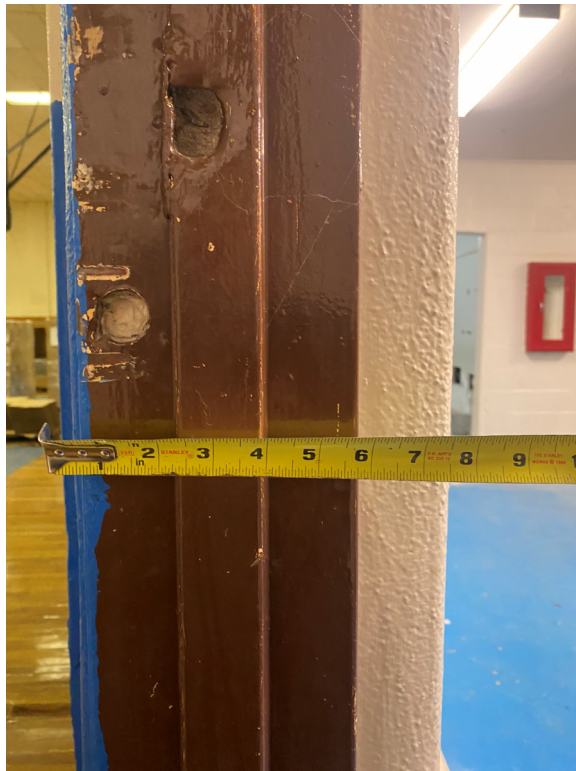
Photo 58 – Gym to locker room, 8-inch masonry wall.

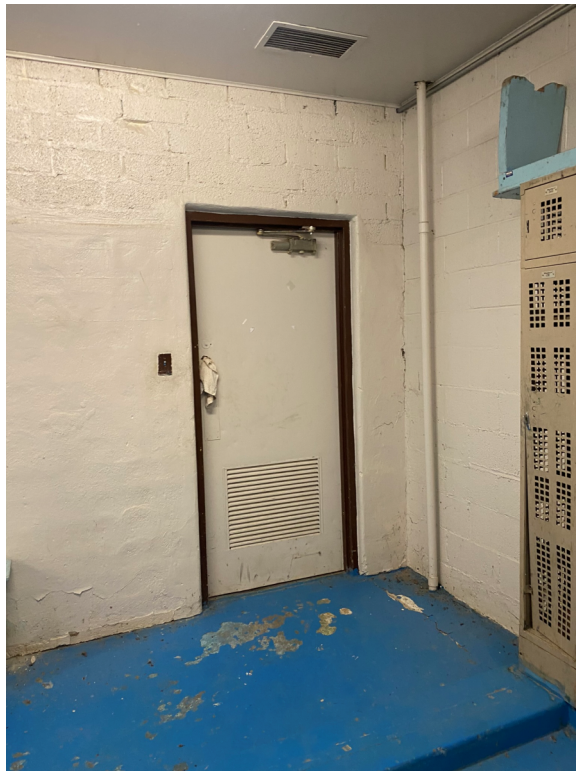
Photo 59 –Gym locker room masonry and brick wall at doorway.

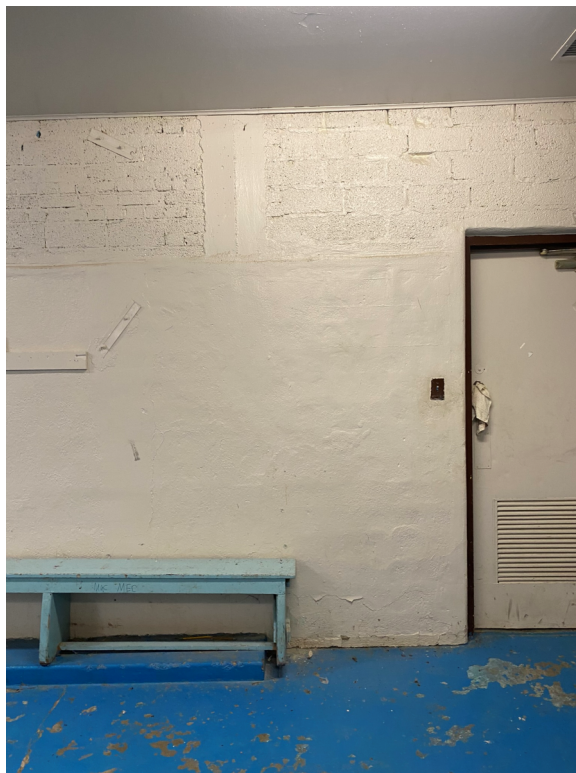
Photo 60 – Gym locker room masonry and brick wall at doorway.

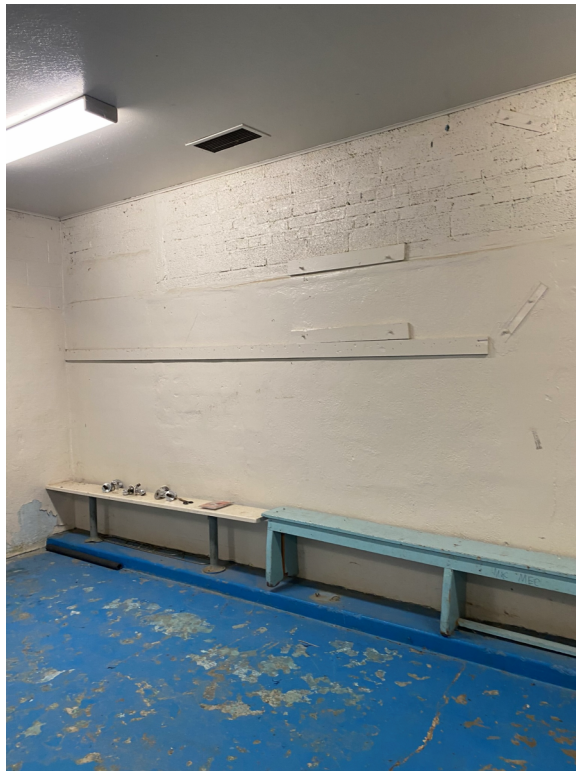
Photo 61 – Gym locker room masonry and brick wall in locker room.

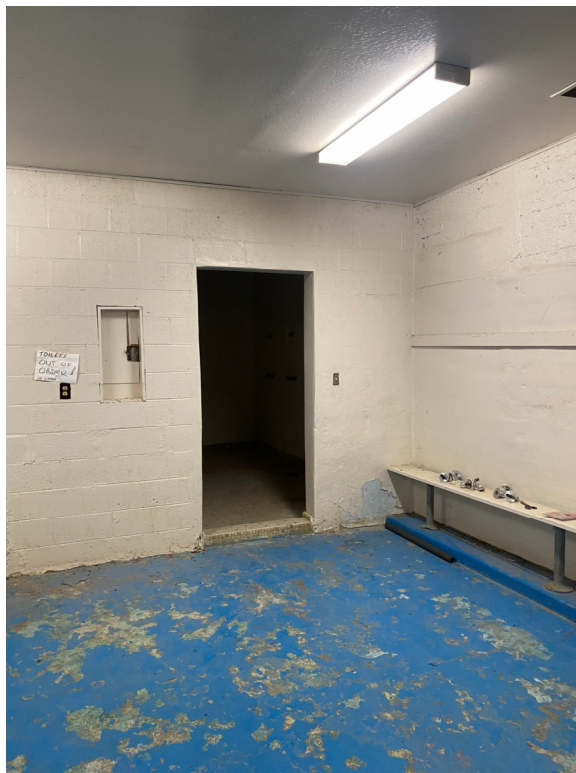
Photo 62 – Gym locker room masonry and brick wall at locker room shower opening.

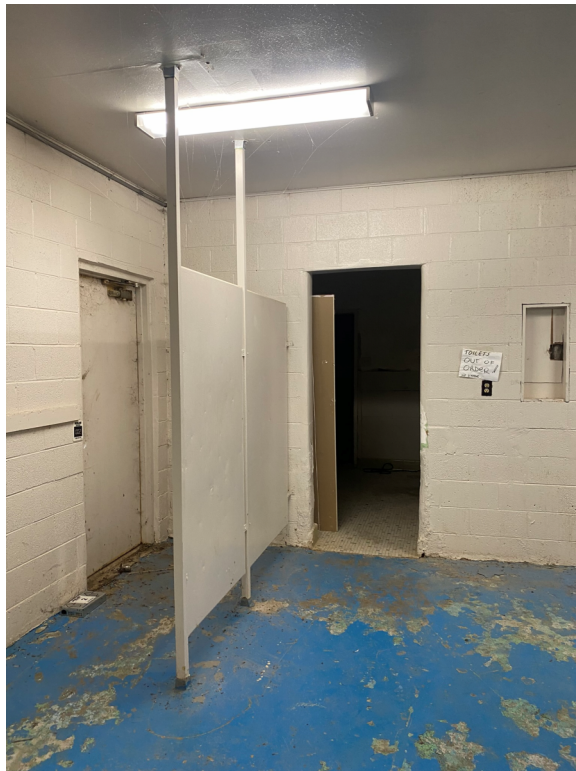
Photo 63 – Gym locker room masonry wall in locker room.

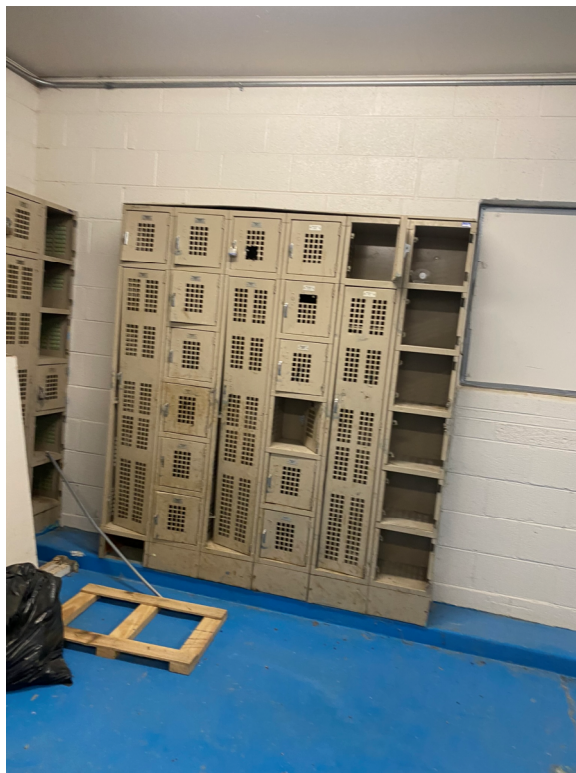
Photo 64 – Gym interior wall in locker room.

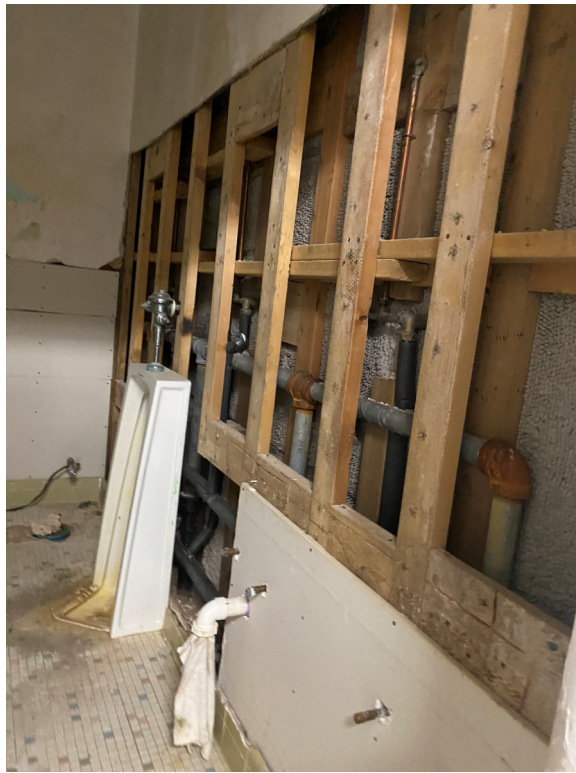
Photo 67 – Gym locker restroom wall with existing plumbing exposed.
